# THE PERRY LITHGOW PARTNERSHIP

15th July 1985

## ROCHESTER CATHEDRAL

### WALLPAINTINGS IN THE CRYPT

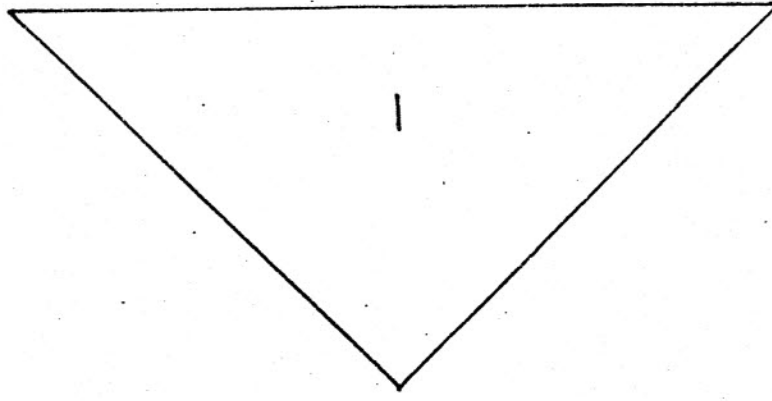
Within this section, centrally placed, is a large cement repair approximately 2'3" x 1'6". Below this and to the south an area of original plaster approximately half the above size is completely missing to a depth of 1½". Other areas, especially around the cement repair and the lower conjunction of the ribs on the north side, have lost their painted plaster. Evidence of recent falls can also be detected on this side.

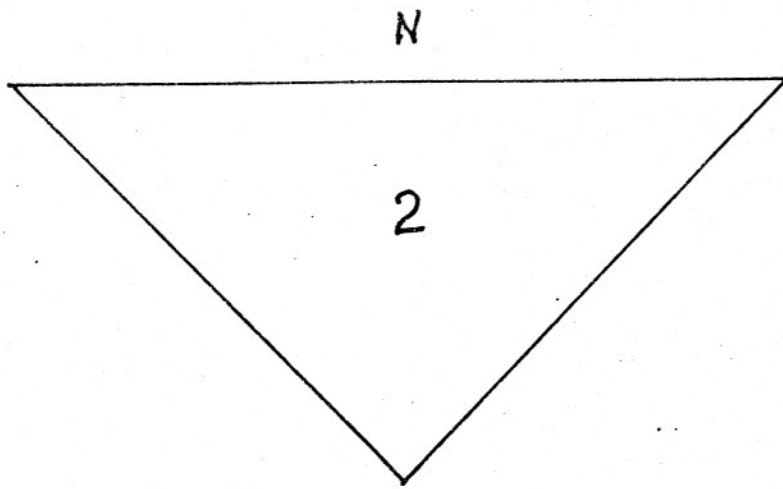
The west side of this section retains 70% of its original paint, but the east side only 5%. At the apex of the vault is a linear crack which appears to be structural and two deep holes where the intonaco plaster is missing. Here to evidence of recent deterioration can be seen on the west side.

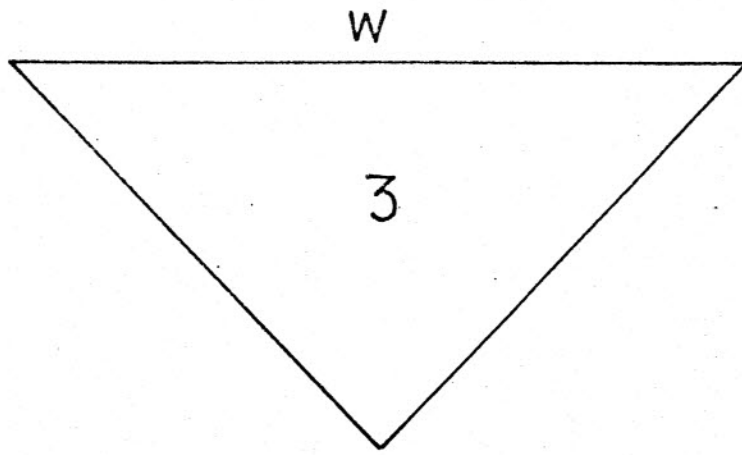
Although a large area at the apex of this vault has lost its paint surface, the sinopia for the roundel can be seen superimposed on the masonry pattern. This effect can also be seen on the lower south side which bears the shield. Lacuna of various depths exist on the upper area and yet more recent deterioration is evident.

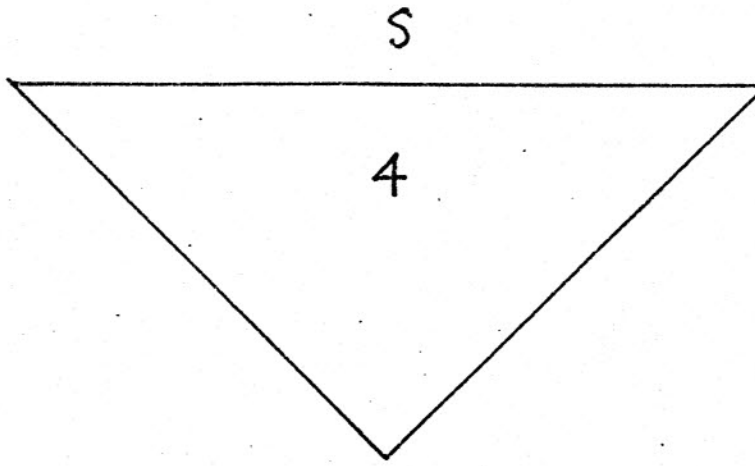
This segment has suffered much damage with 70% of the intonaco plaster lost on the east side and considerable paint loss on the west side. The plaster at the apex has exfoliated in a highly dangerous manner and must be considered to be in immediate peril.

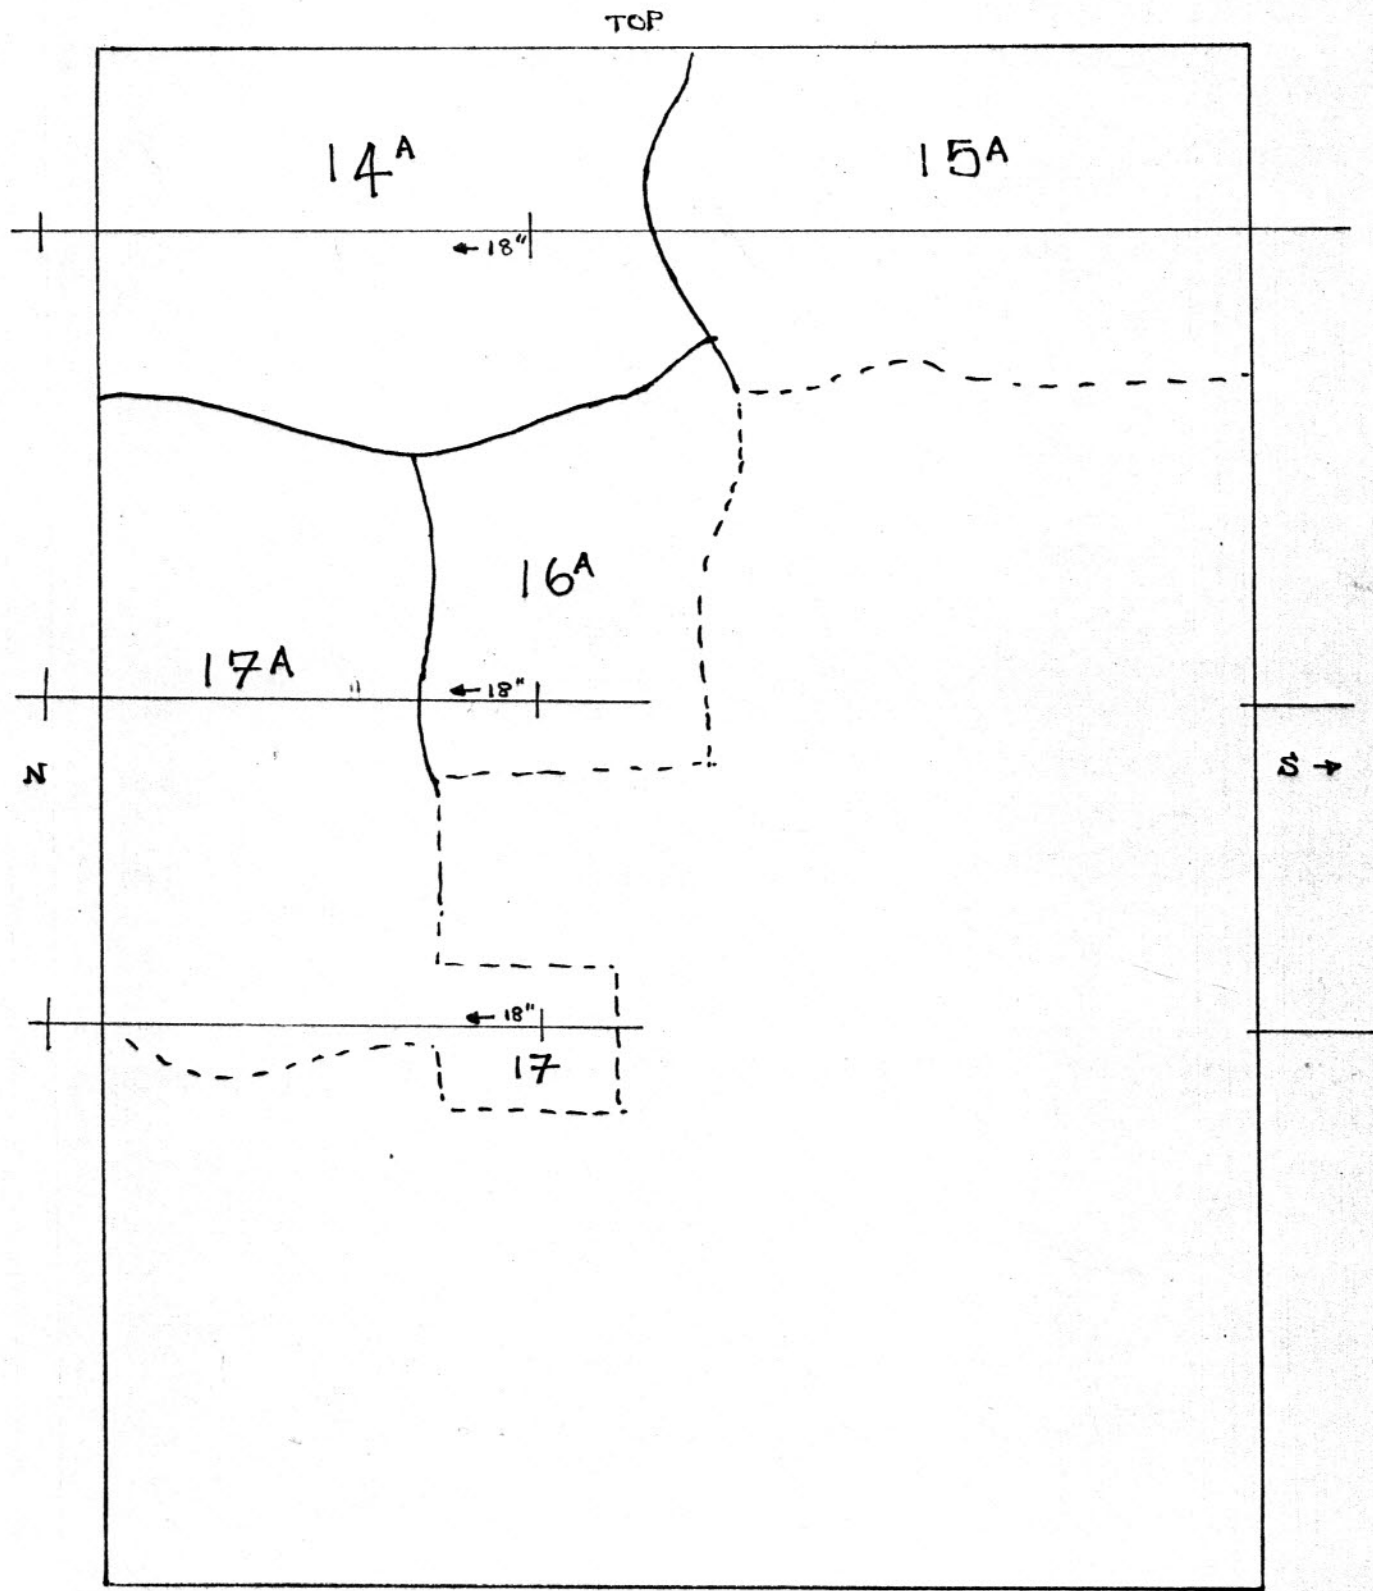
JB. The mortar is about 1/4" thick over the stones on the edges of the arches. EAST HALF OF SOUTH ARCH (BLACK A)
