15 May 1996

Conservation Record

ROCHESTER CATHEDRAL: CRYPT

1996 WALL PAINTING CONSERVATION PROGRAMME

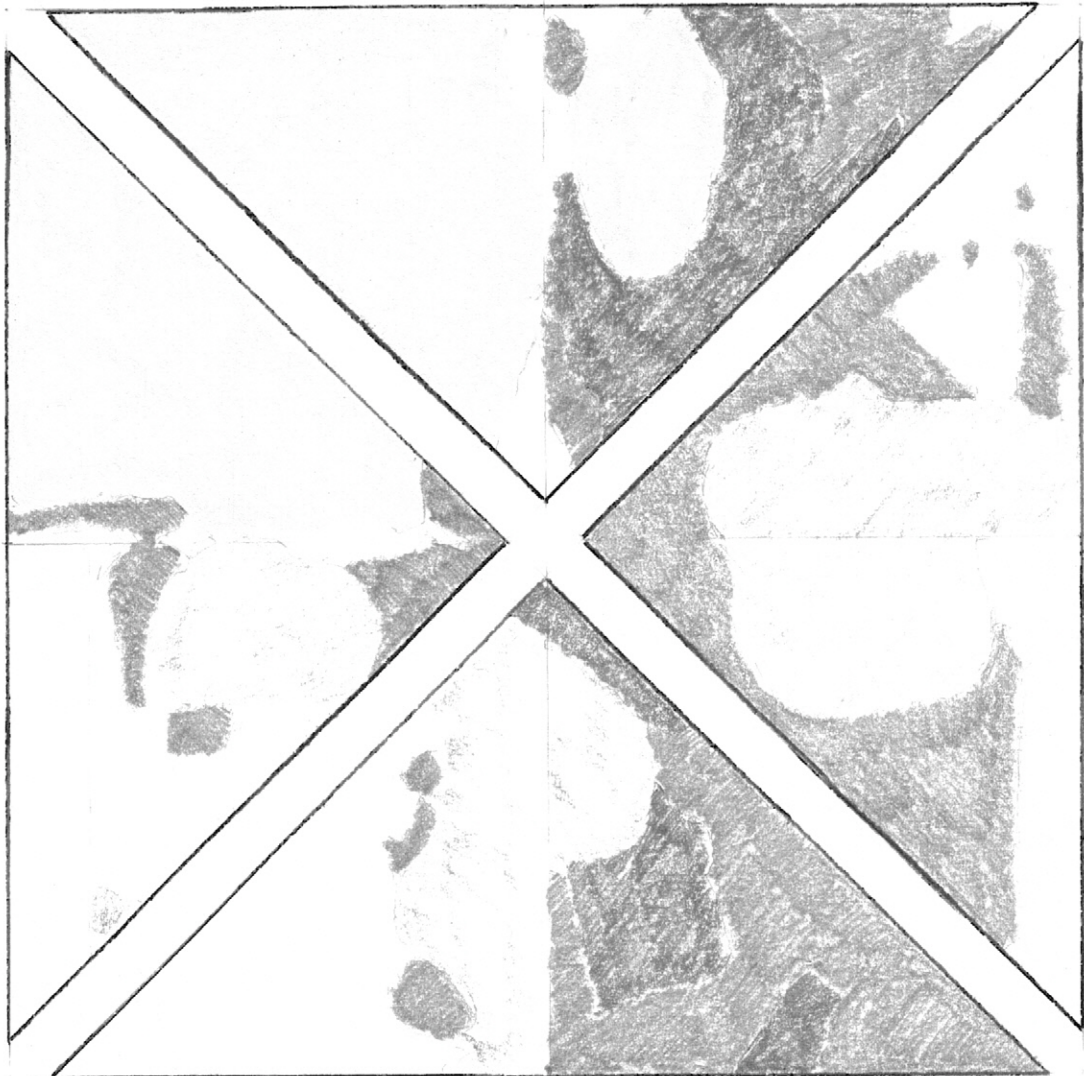
ROCHESTER CATHEDRAL CRYPT - BAY D11 - VIEW LOOKING UP
 DIAGRAM SHOWING BACKING PLASTER BEFORE APPLICATION OF
 PERRY-LITHGOW SKIM COAT

As this vault had never contained any original painted plaster and was now the site of the main crypt altar, it was proposed that this bay would be redecorated with a new wall painting. It was suggested that a test area be produced by us to illustrate a design proposal. To this end the vault had been repaired by Nimbus (photographs 107-110) but the work was found to be of insufficient quality on which to paint and the whole vault area had to be treated again by us. This involved the removal of all non-original surfaces back to a solid base and the gradual building up of new plaster as detailed above (photographs 111-114). A detailed record was kept of all periods of repairwork and this appears in the appendix.
