# THE PERRY LITHGOW PARTNERSHIP

## ROCHESTER CATHEDRAL

### William of Perth Tomb (c.1350)

### The Crypt - Eastern End, South East Bay

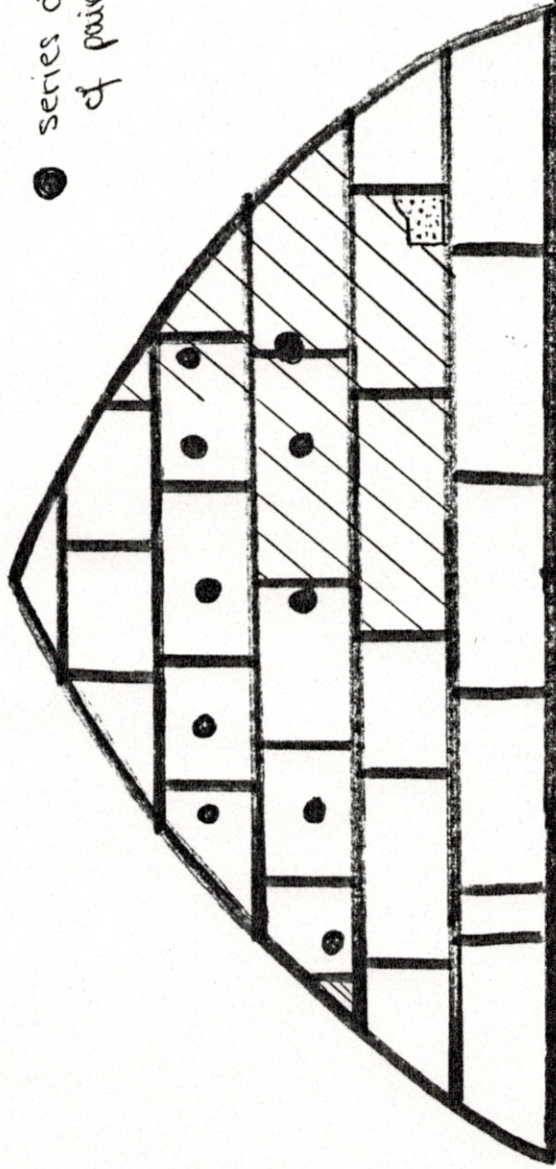
DIAGRAM I

in strength and condition. Diagram I shows a large area of blooming of the paint, leading to a discolouration of the red pigment. This was probably due to increased salts action in these stones, but because a small stone on the far left of the recess was also affected, it would seem to suggest a weakness in the stones allowing the salts to move outward more easily, rather than just a localized problem.

The cleaning and limewash removal on the painted recess revealed a series of regular round losses (Diagram I) which seems to indicate that something, possibly a drape of some sort, was attached to the painting at one time, though because the stone is not damaged it would seem to have been stuck on to the surface of the painting.

AREAS OF BLOOMING AND DISCOLORATION

series of corresponding areas of paint loss

The final phase of the programme was to tone down the areas of paint loss on the recess. This was carried out with earth pigments mixed with water using the 'Tratteggio' technique for the smaller areas and a simple tonal wash over larger areas. Since there was so much loss it was deemed necessary to try and give an impression of how the original decoration may have appeared, although the conjectural reconstruction was undertaken - indicated by leaving the birds untouched - as it would be both impossible and imprudent to attempt any such reconstruction where so little of the original remains.

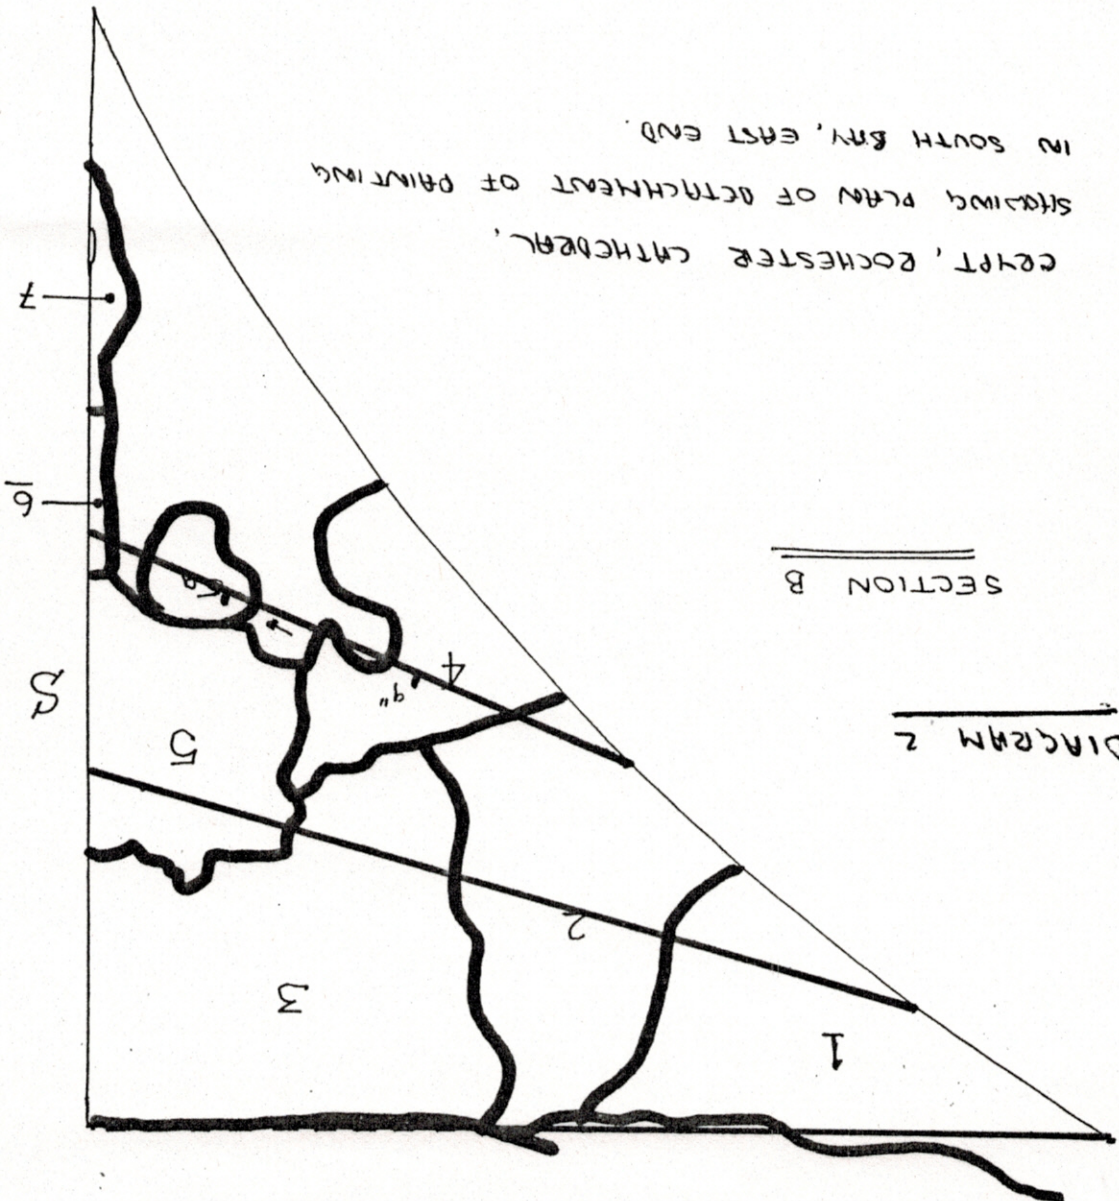
DIAGRAM 2

CEPT, ROCHESTER CATHEDRAL,  
STUDY PLAN OF ATTACHMENT OF PAINTING  
IN SOUTH BAY, EAST END.

The painting was cut down in the manner shown on Diagrams 2 and 3 and the plaster removed often to a depth of 4 inches. A fresh lime/sand mortar in a 1:2 mix using
