**ROCHESTER CATHEDRAL**

**CHOIR SCREEN PAINTED DECORATION AND  
FRAMED CHOIR SCREEN BOARDS**

**Condition Survey and Treatment Proposals**

**Richard Lithgow**  
**January 2017**

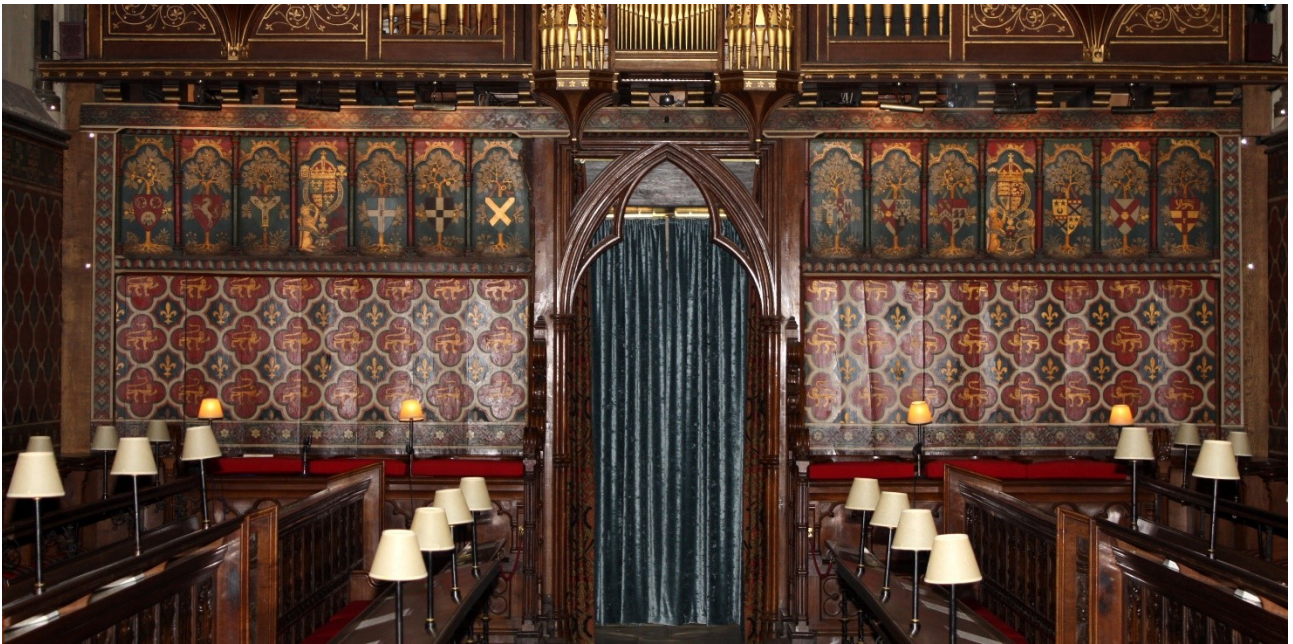
Fig 1. The east-facing Choir screen boards

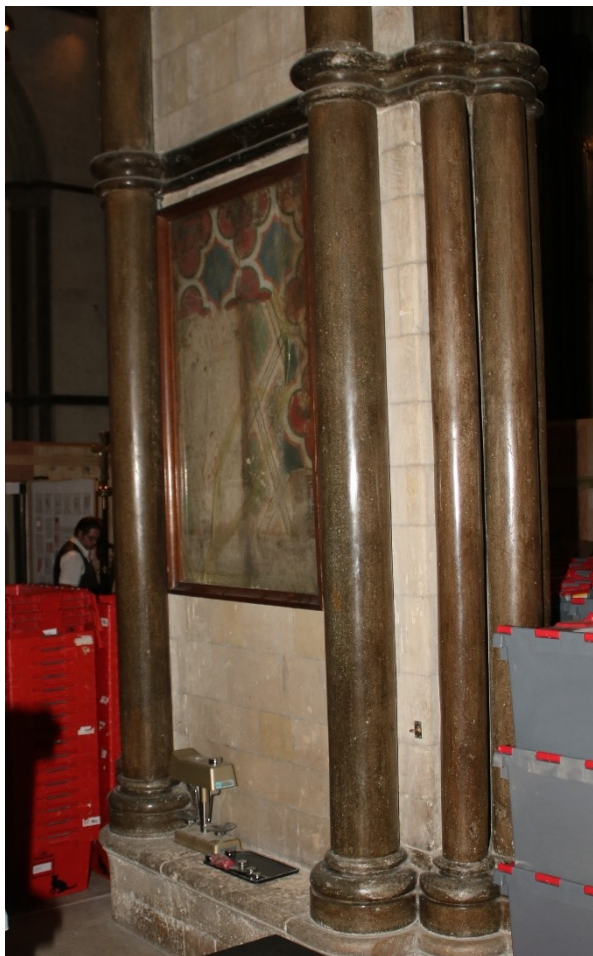
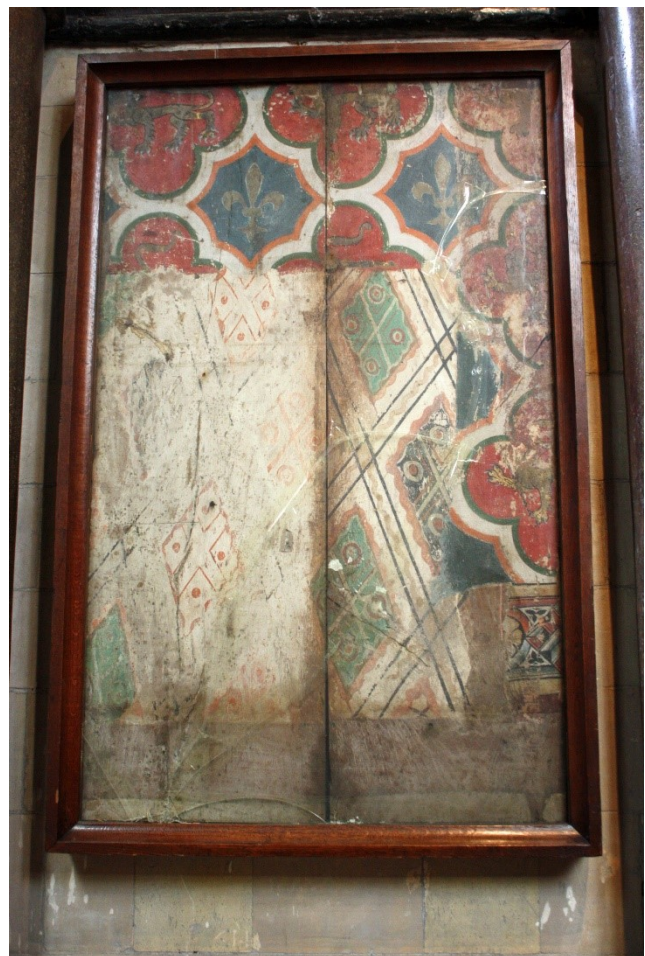
Fig 2. The framed panel of two detached Choir screen boards on the south face of a pier in the South Choir transept.

The Perspex glazing the framed boards is cracked and broken. The damage is not recent but evidently caused by forceful impact to the lower section.

The strategy for treatment is to remove the painted boards from the 19<sup>th</sup> century frame; stabilise the flaking paint layers; consolidate localised areas of insect damage; reduce/remove the wax-based surface coating; replace the existing fractured glazing with non-reflective, UV resistant glass; then reinstall the boards in the existing frame using stainless steel fixings and a breathable backing. The cathedral will make arrangements for the conserved and re-glazed framed boards to be mounted for display on the north-face of the South Choir Transept pier using the same system of threaded bolts to hand the frame.

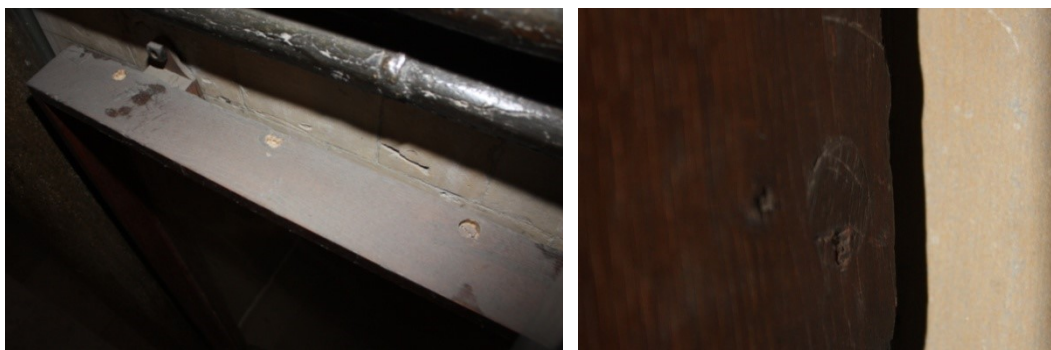
Fig 2. Countersunk screws on the side and bottom are covered by oak plugs.

The boards are secured in the frame by large screws (c. 4 top and bottom 6 on either side). The screws heads are countersunk in the frame and disguised by oak plugs. The frame is fixed in place by two metal plates hung from steel bolts (set into the pier immediately below string course): the metal plates spaced back from the frame by wood blocks.

Taking into account the thickness and weight and condition of the boards, as well as budgetary concerns, the aim will be to re-use the existing frame and re-fix the boards using stainless-steel screws in the existing screw holes. The furniture conservator will disguise the countersunk screw heads with oak plugs stained to match the frame.

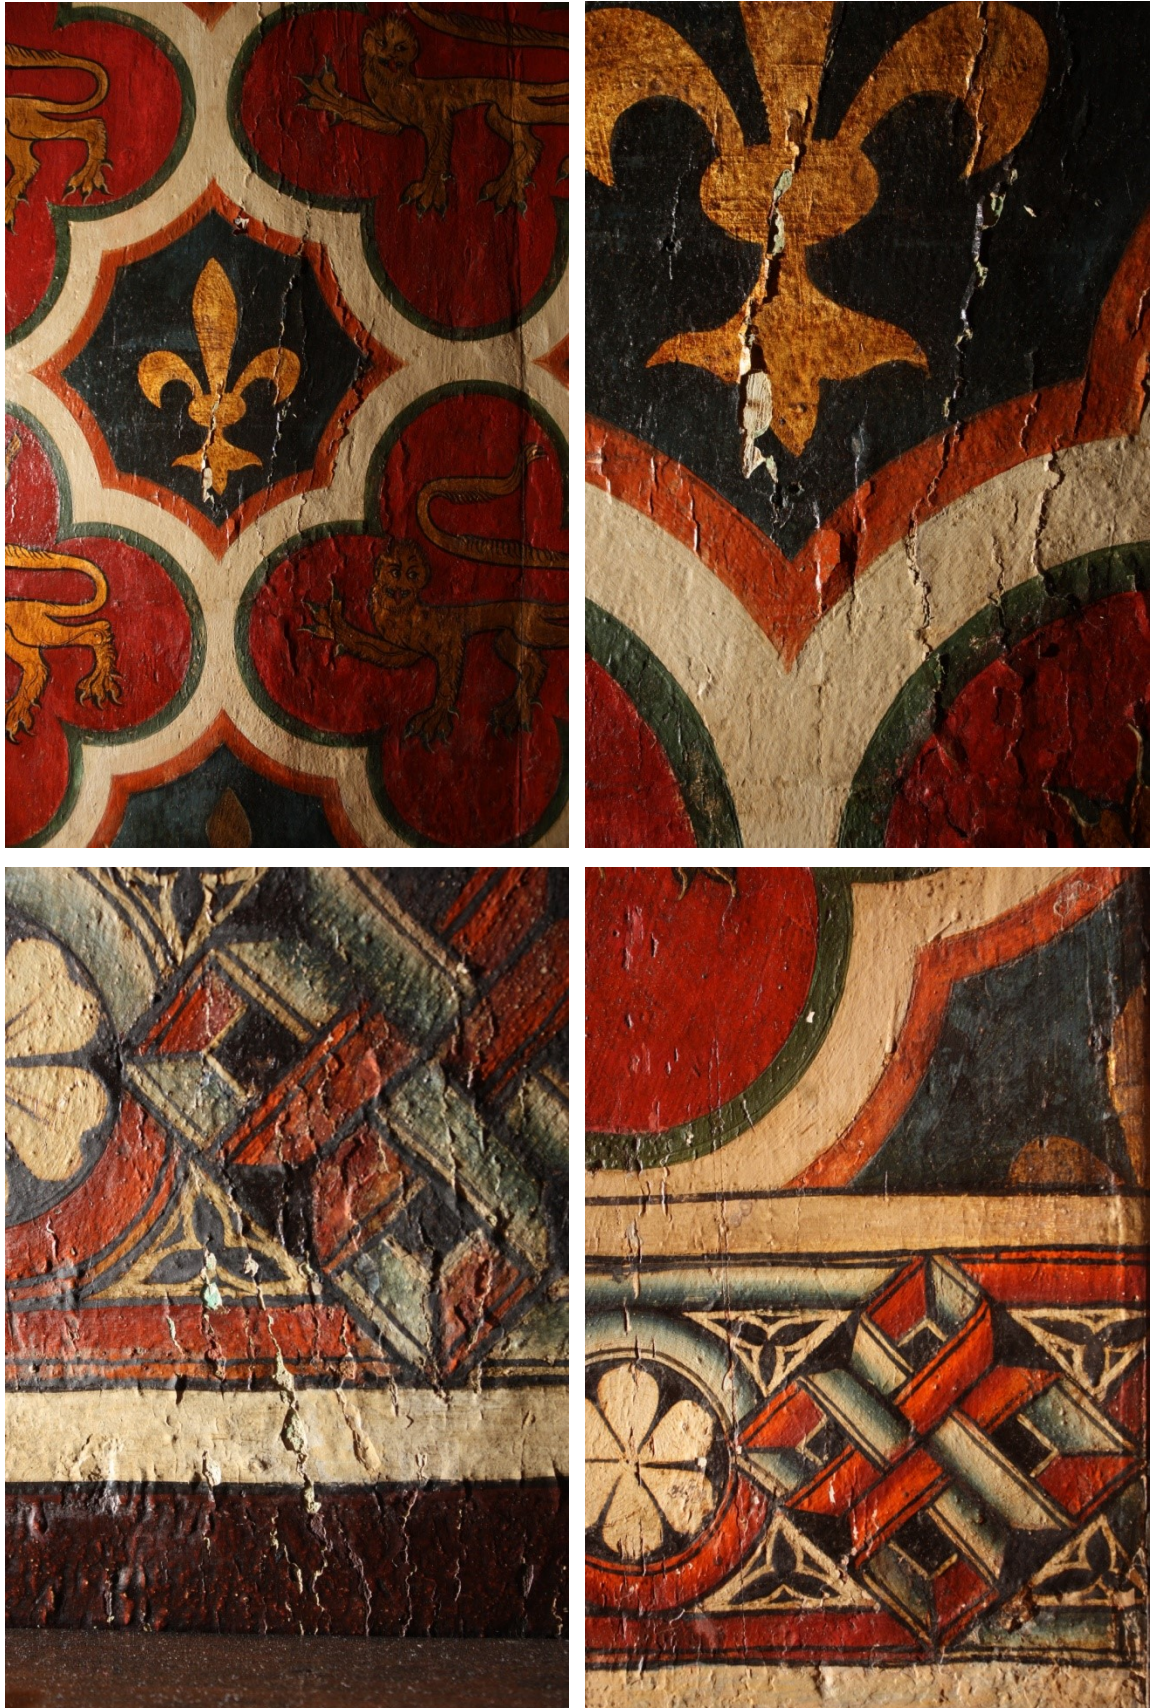
Fig 2. Raking light details of lifting and flaking paint.

Whilst most of the painted decoration is stable there are significant areas of lifting, flaking and loss from boards across the width of the screen. These areas of damage are marked on the accompanying graphics. Some of the damage takes the form of tenting in vertical lines suggesting swelling/shrinkage of the boards. There are also narrow cracks along some of the vertical joints. The appended graphics also show which boards and timbers are nineteenth century replacements.

Recent monitoring found environmental conditions in the main body of the cathedral to be relatively stable so one can only speculate that heat from machinery associated with the organ workings housed behind the boards may be one cause. Some of the loss, particularly just above the stalls, may result from dusting the loose paint or accidental impact.

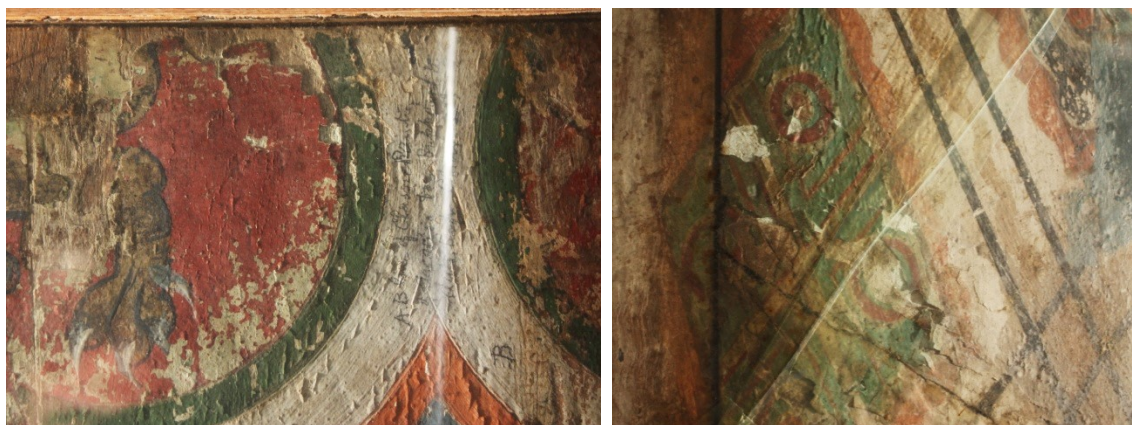
Fig 3. Raking light details of lifting and flaking paint

The cracked and broken glazing affords inadequate protection to the unstable paint layers and, in places, is in direct contact with lifted flakes. Some paint flakes have already detached, their fragments now lodged at the bottom of the frame.

A slight surface sheen indicates there may be a thin surface coating overall (possibly wax-based). The two main areas of flaking appear to have an initial, thicker coating, probably applied in the 19<sup>th</sup> century to stabilise flaking paint. In places the thicker coating has bloomed slightly giving the surface a cloudy appearance.

variation due to the sun's radiant heat will continue to affect both the paint and surface coating(s) and undoubtedly will have been partly responsible, for the recurrence of lifting and flaking paint. The cathedral FAC have decided that the conserved framed boards should be relocated to the opposite (north) face of the South Choir Transept pier. A similar arrangement of iron bolt fixings to be installed while the treatment works are in progress

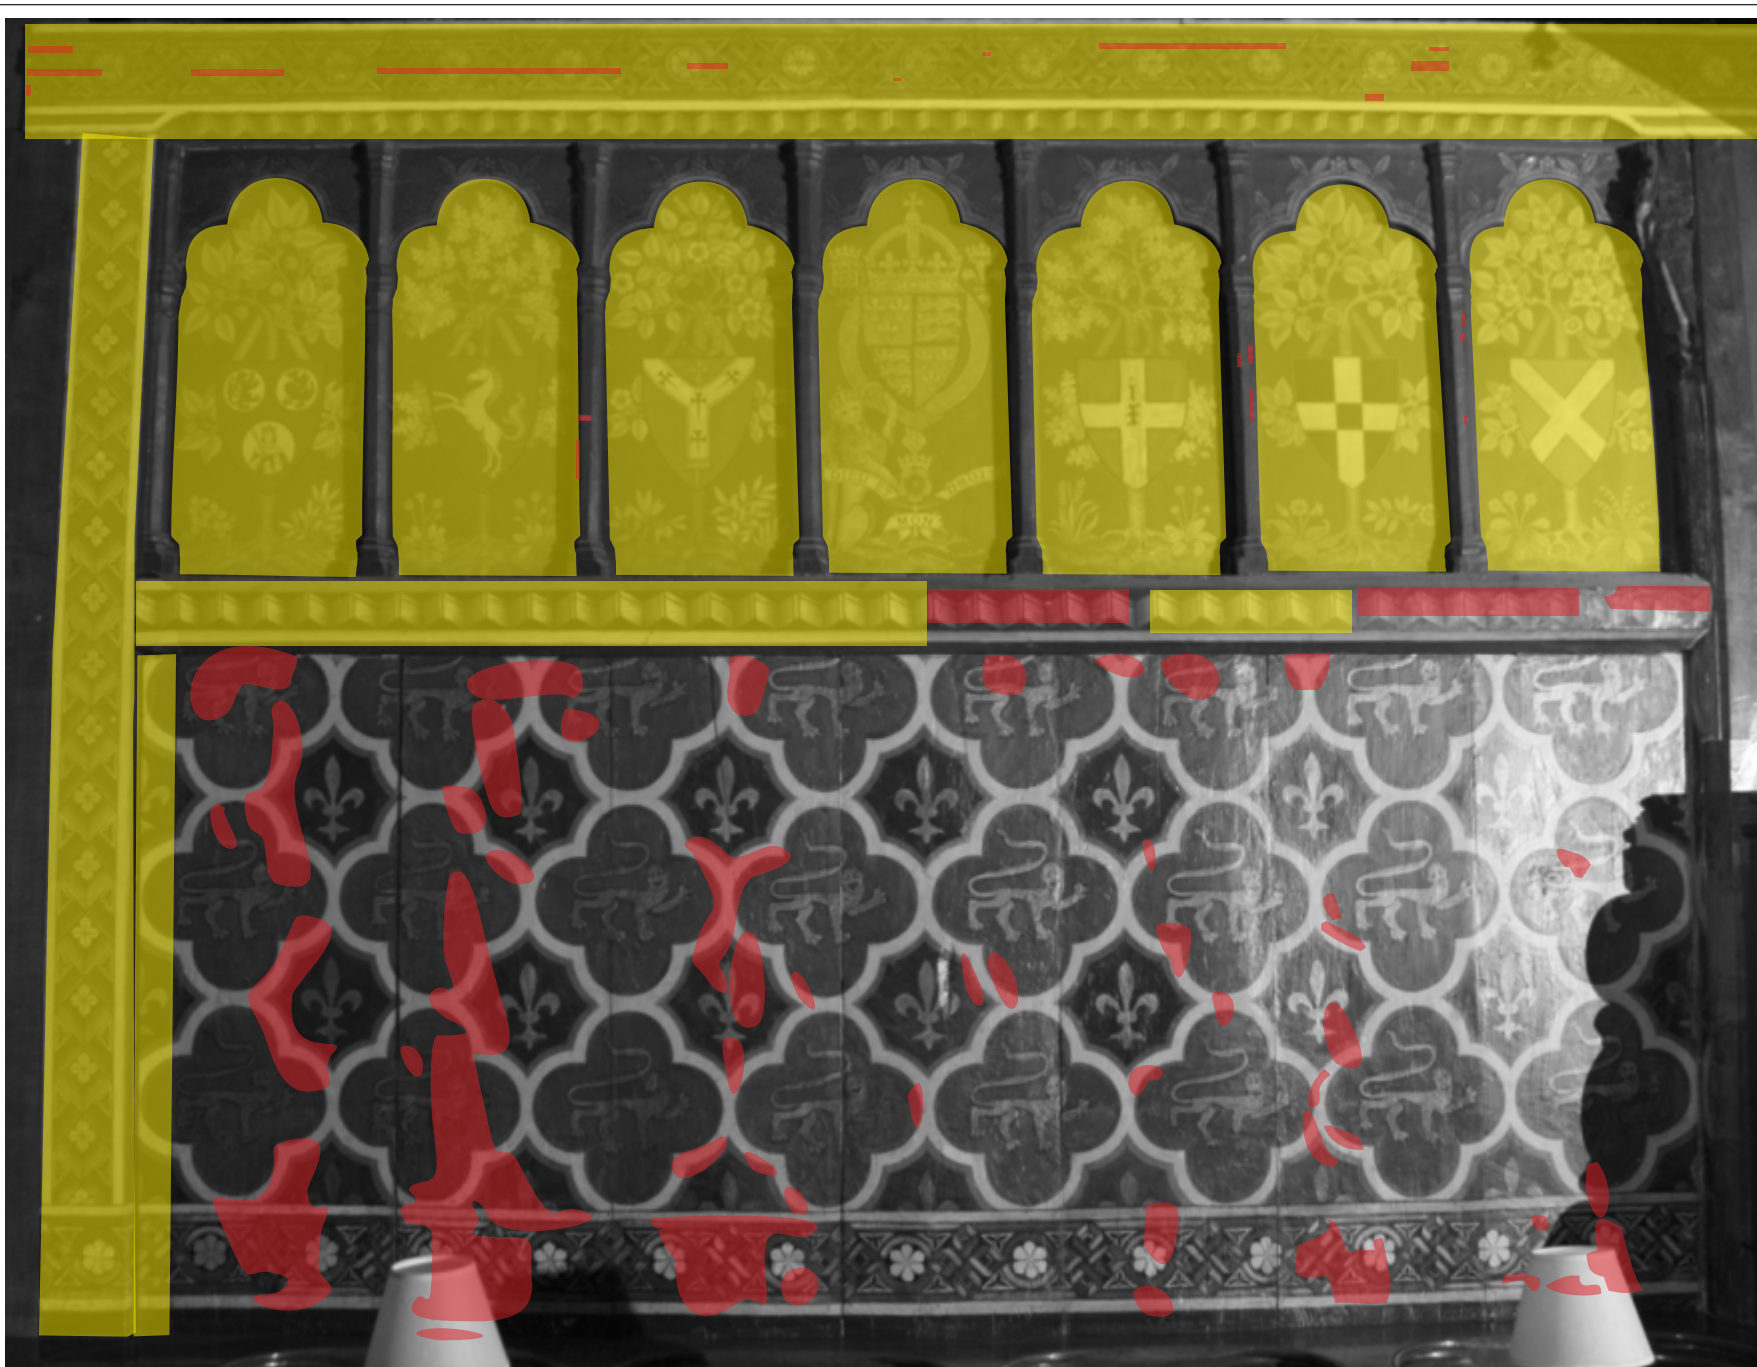
AREA  
CHOIR SCREEN  
EAST FACE, SOUTH SIDE

It is not known what measures (if any) were taken by the 19th century restorers to stabilise the 13th and 14th century layers prior to overpainting, but the uneven surface suggests there had been significant loss of the early paint schemes prior to the 19th century repaint.

There is evidence of some retouching over 19th century paint loss - presumably the retouching dates to the 1992 intervention. It would be helpful to study the 1992 treatment record but it has not been found in the cathedral records.

Whilst most of the painted decoration is stable there are significant areas of lifting, flaking and loss from boards across the width of the screen. These areas of damage are marked on the accompanying graphics. Some of the damage takes the form of tenting in vertical lines suggesting swelling/shrinkage of the boards. There are also narrow cracks along some of the vertical joints. Recent monitoring found environmental conditions in the main body of the cathedral to be relatively stable so one can only speculate that heat from machinery associated with the organ workings housed behind the boards may be one cause. Some of the loss, particularly just above the stalls, may result from dusting the loose paint or accidental impact.

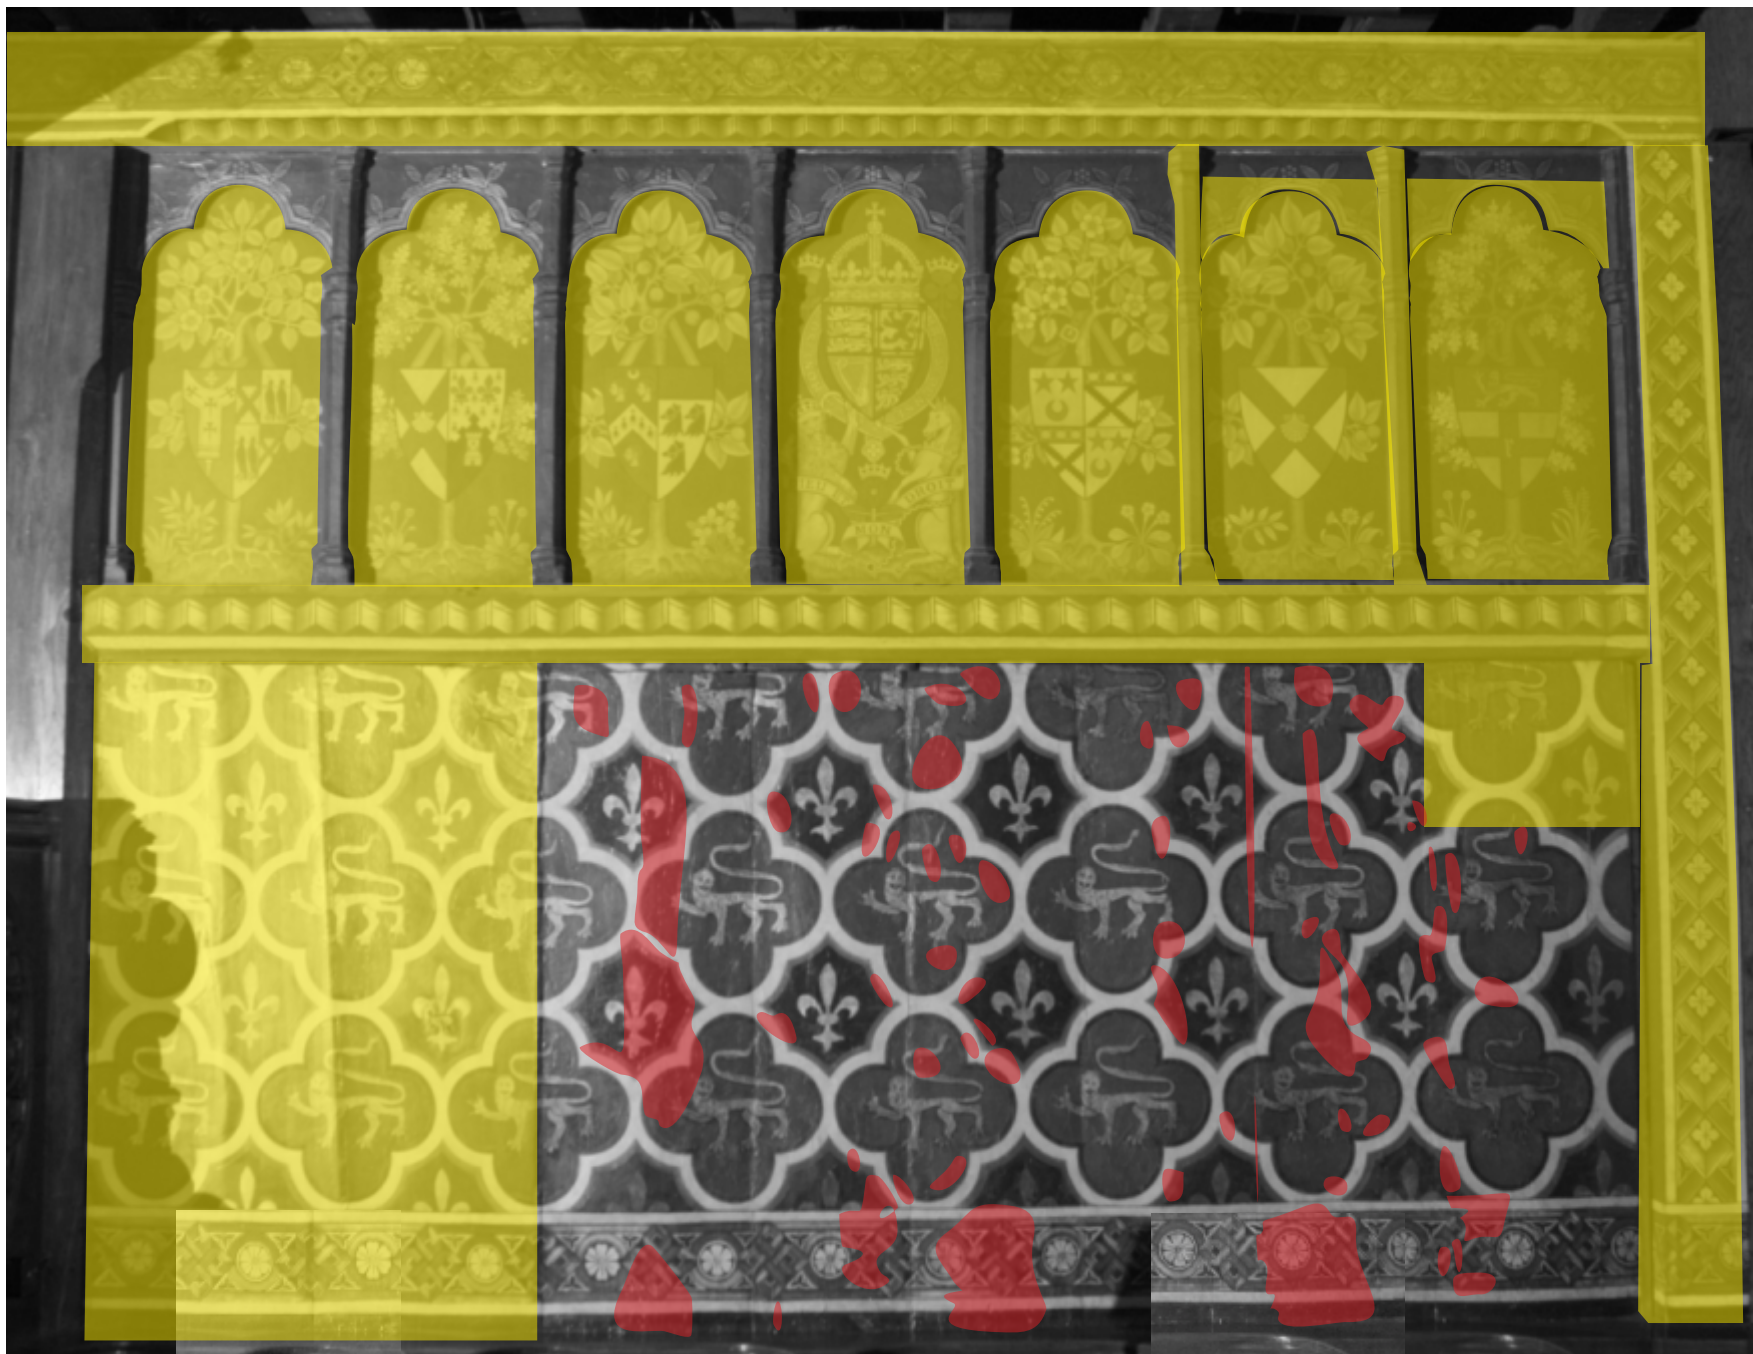
It is not known what measures (if any) were taken by the 19th century restorers to stabilise the 13th and 14th century layers prior to overpainting, but the uneven surface suggests there had been significant loss of the early paint schemes prior to the 19th century repaint.

There is evidence of some retouching over 19th century paint loss - presumably the retouching dates to the 1992 intervention. It would be helpful to study the 1992 treatment record but it has not been found in the cathedral records.

Whilst most of the painted decoration is stable there are significant areas of lifting, flaking and loss from boards across the width of the screen. These areas of damage are marked on the accompanying graphics. Some of the damage takes the form of tenting in vertical lines suggesting swelling/shrinkage of the boards. There are also narrow cracks along some of the vertical joints. Recent monitoring found environmental conditions in the main body of the cathedral to be relatively stable so one can only speculate that heat from machinery associated with the organ workings housed behind the boards may be one cause. Some of the loss, particularly just above the stalls, may result from dusting the loose paint or accidental impact.

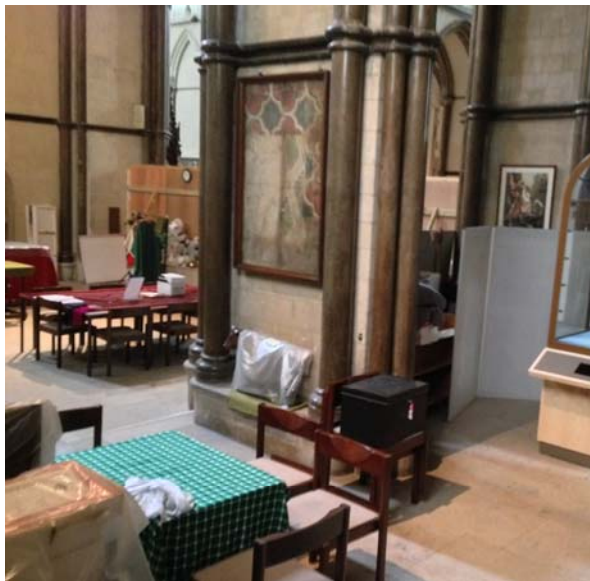
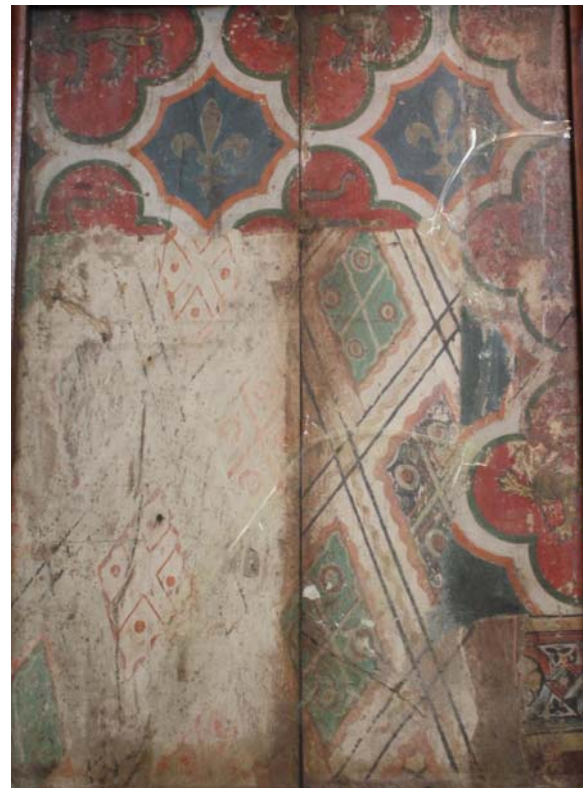
Figures 1 & 2. General view of the panels in the south aisle and detail of the panels.

The panels are mounted in a heavy timber frame with a sheet of thin picture glass set between approximately 1mm and 10mm from the surface of the panel (due to the irregularity of the wood). The panels are exposed at the back and there is no backing board.

Although the frame appears to be in good structural condition with one or two minor areas of impact damage, the glass is broken in a number of areas and is secured with adhesive tape. At the bottom of the panel the broken shards of glass press against the painted surface.

It is understood that the glass pane is to be repaired and replaced with a suitable pane of reinforced glass fixed away from the paint surface. The resulting enclosure of the panel will further increase the level of hygral buffering to which the surface of the panel is exposed. While this might be a concern if the reverse of the panel were exposed to significantly different conditions, in this position on an internal wall, it appears that the risk is low. However, consideration should also be given to increasing the depth of the frame to allow the installation of a backboard, enclosing the painted panels.

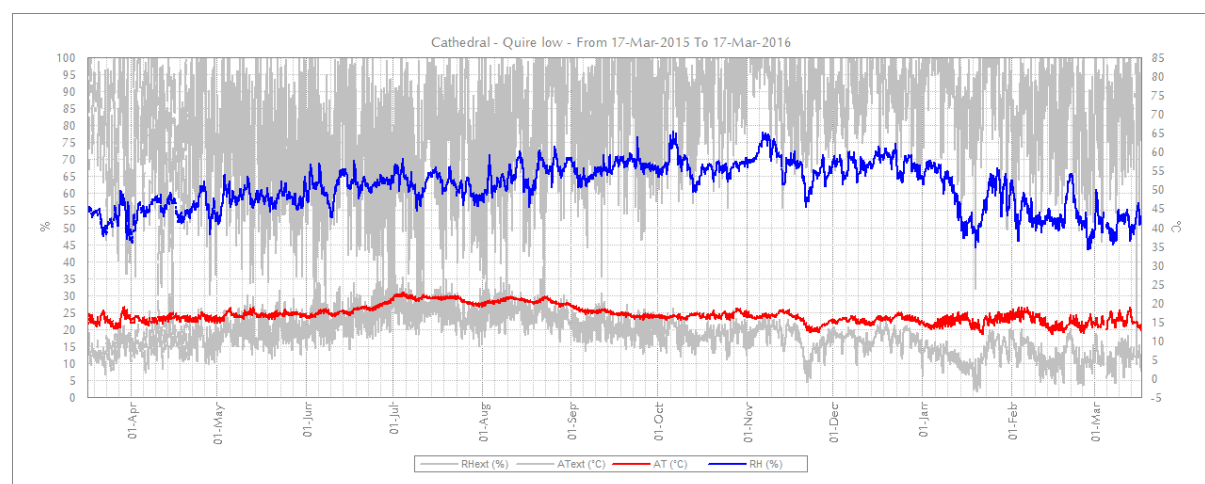
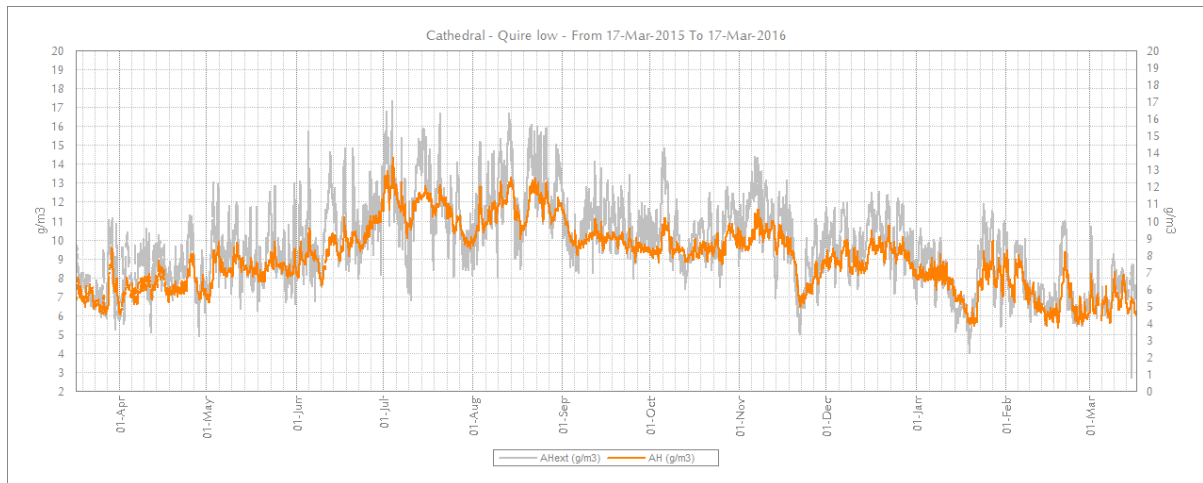
Environmental monitoring undertaken in the quire between 2012 and 2016 indicated that the building envelope provided a high level of both thermal and hygral buffering between the internal and external conditions.<sup>3</sup> As a result, large changes in the external weather are likely to be reflected by any small changes within the body of the cathedral. Stability was undermined by internal/external air leakage as can be seen from the AH data.

Annual RH data was generally in the band 45%-70% with occasional fluctuations above and below, particularly in periods when there was excessive external air leakage due to building work.

Figures 3 & 4. RH, T and AH data showing the comparatively stable conditions in the quire.

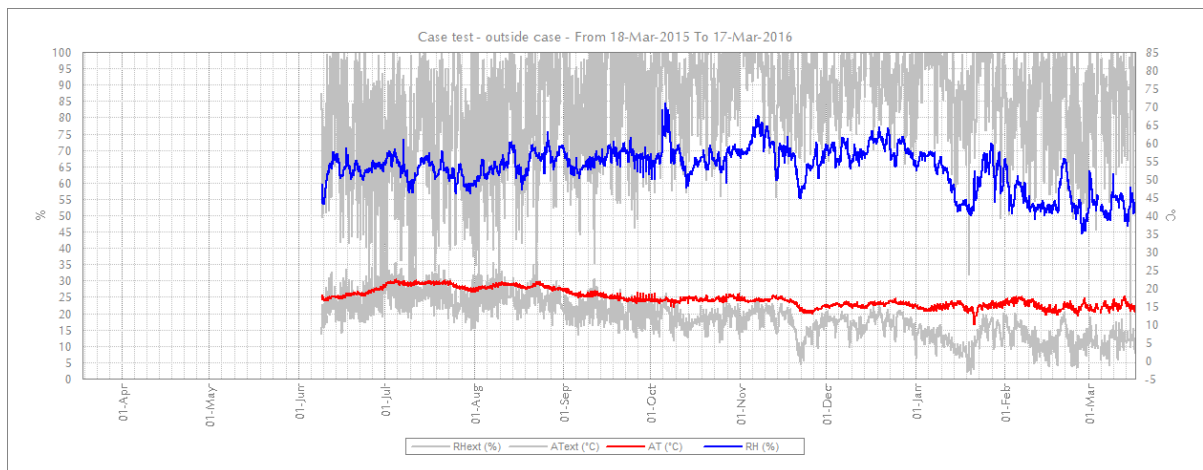
Data collected in the south aisle since June 2015, close to the framed panels, indicated that conditions in this area are similar to that than within the body of the quire.

Figure 5. Data from the south quire aisle showing similar conditions to those within the quire itself.

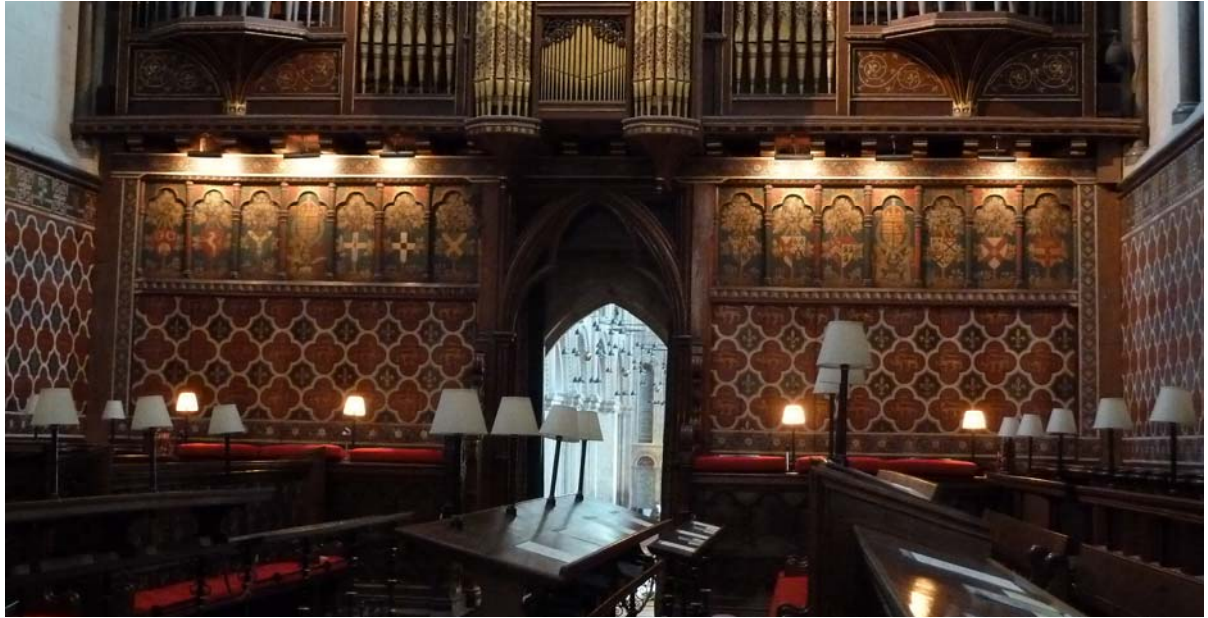
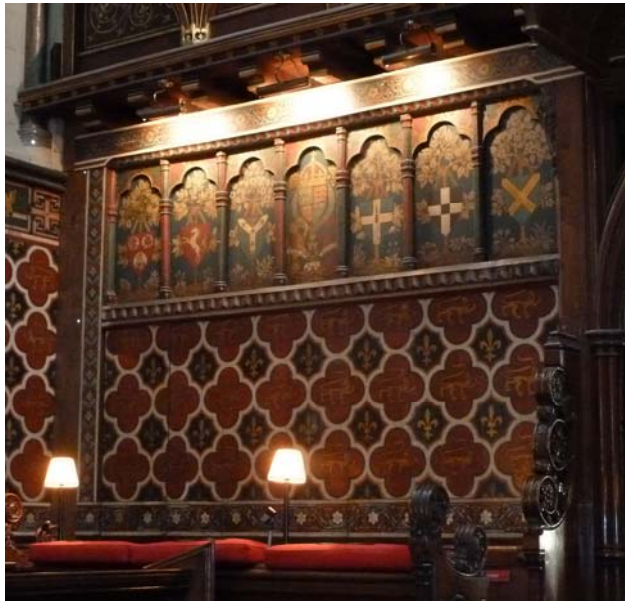
The panels in the main pulpitum screen have suffered from minor delamination of the paint layer, indicating a small level of movement in the timber substrate at some point in the last century, which is possibly ongoing. No obvious stress lodging or other movement factors were observed and this appears likely to be associated with local environmental factors.

Figures 6 & 7. General view of the screen on the east side of the pulpitum and detail of the south side.

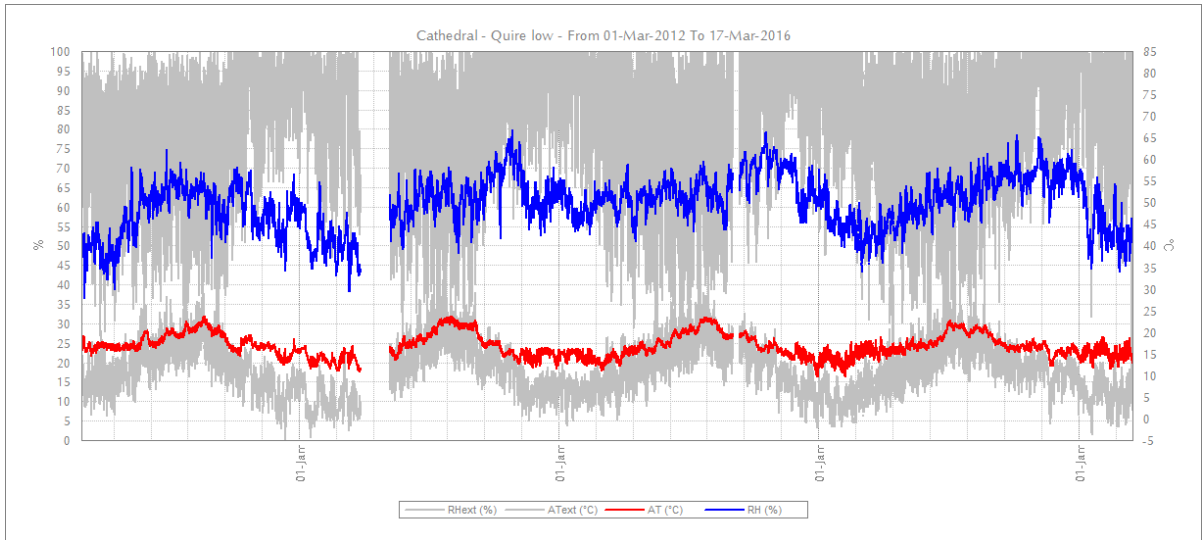
A review of the monitoring data from the quire discussed above indicated that RH conditions in the quire are comparatively stable generally remaining in the 45%-70% band.

Figure 8. RH and T conditions in the quire between 2012 and 2016.

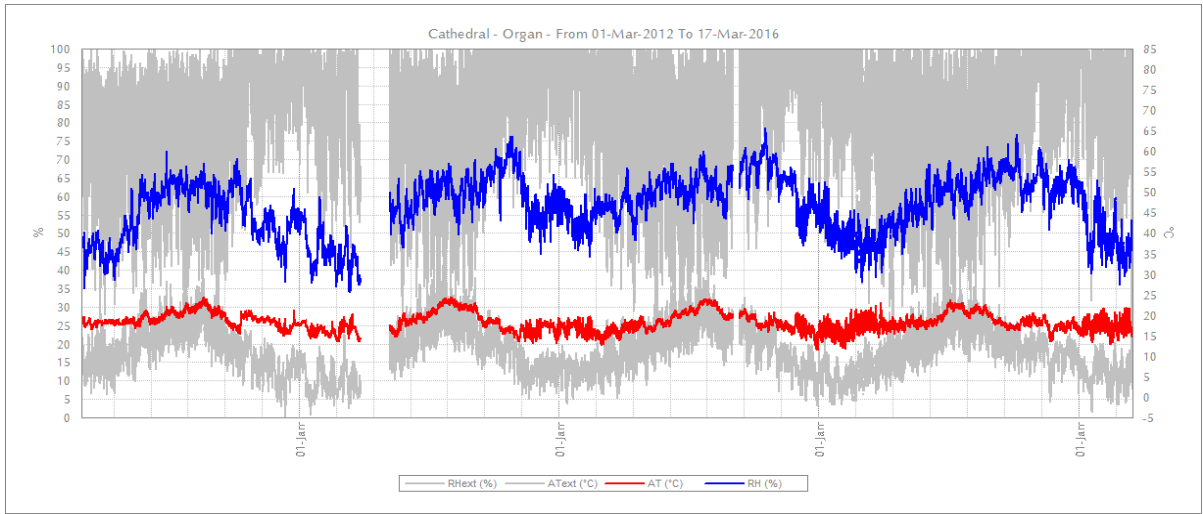
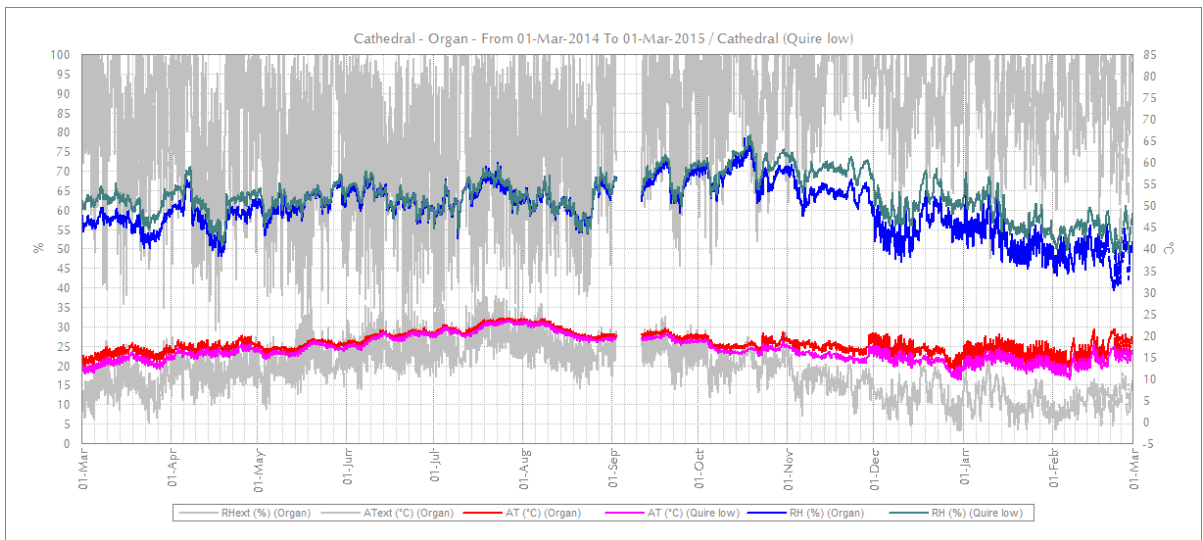
Conditions in the organ itself were similar in the summer but, during the winter, when the heating was in operation the T was notably higher with the RH falling lower. It is possible that if the conditions behind the screen are similar to those in the organ that a thermal and hygral gradient may exist which would cause uneven dimensional response and, in due course, further investigations should be undertaken.

Figures 9 & 10. Conditions in the organ and a comparison in 2015/2016 with conditions in the quire.
