*Conservation of  
Wallpaintings, Gildings & Polychrome.*

**Rochester Cathedral**

**Quire Leopards**

### Report on the Conservation of the Quire Leopards 19.01. - 12.03.1993

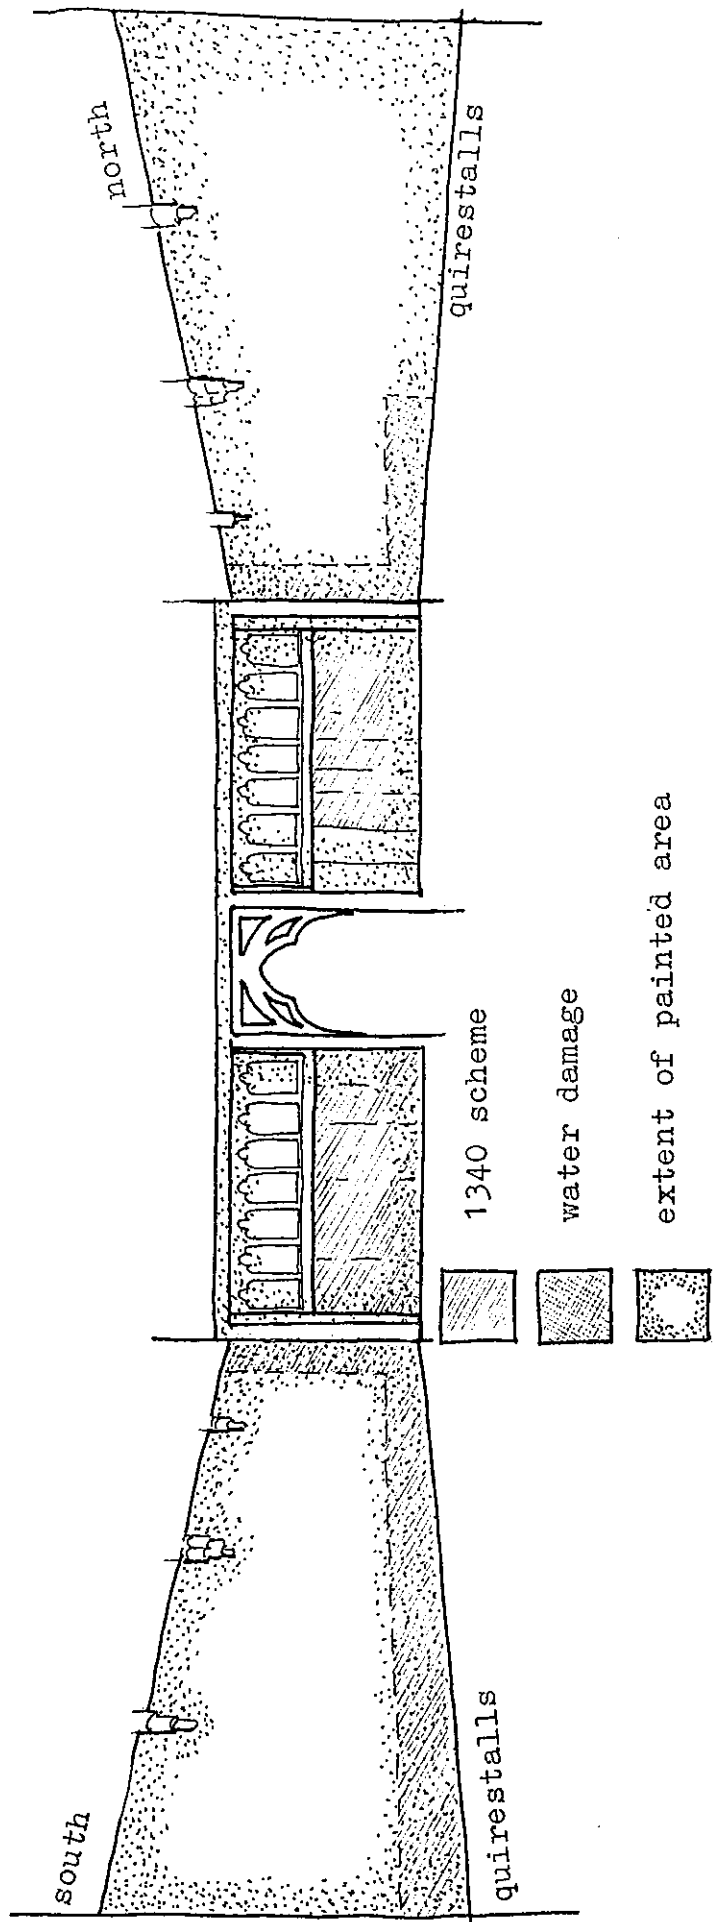
hand sketch - not to scale

There is mediaeval decoration on the wooden (oak?) boards of the pulpitum (except for two planks on the northern side abutting the gate, which are a 1874 replacement). It extends at full height some 80 centimetres onto the ashlar of the north and south walls. There also survives a narrow strip of mediaeval decoration - circa 30 centimetres high - above the quire stalls, the full length of the wall on the south side and some 4.5 metres on the north wall. ( see sketch )

There was evidence of past paintloss on the stone. Large areas were retouched. A strip of 1.5 metres at the east end of the north wall appear to have been severely damp damaged at some time in the past (see sketch and photograph 18).

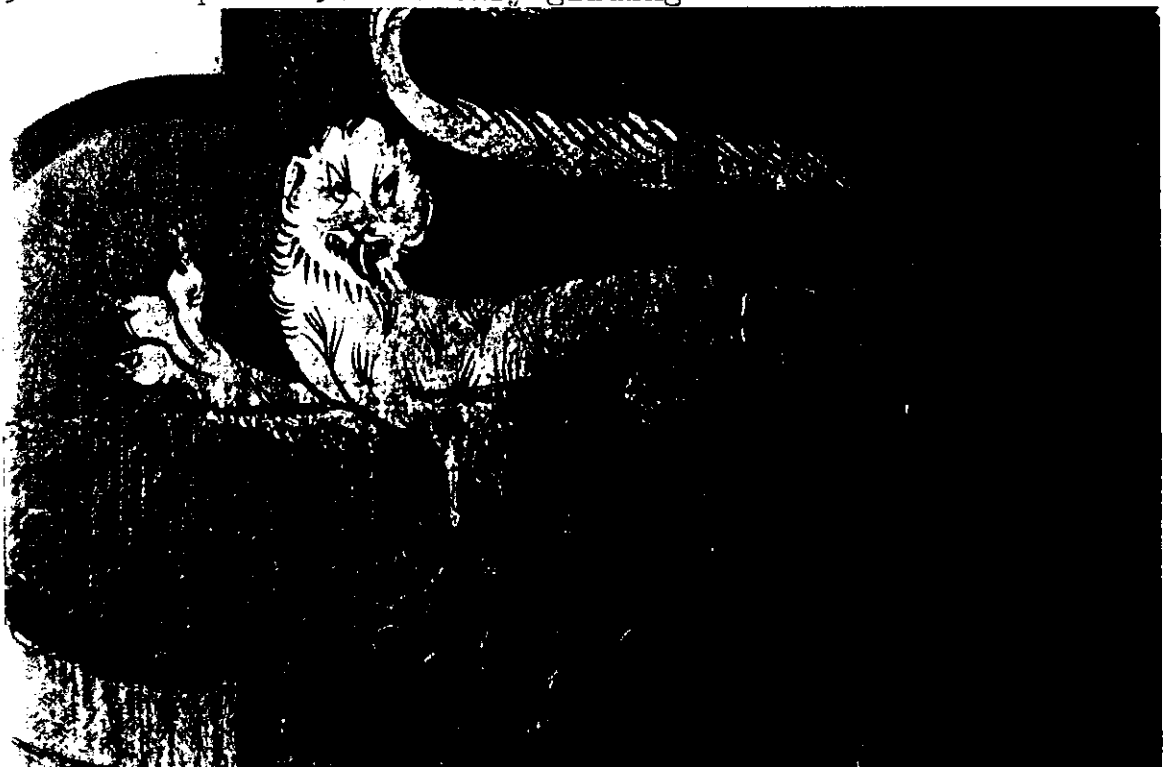
3. overlap of 19th century gilding

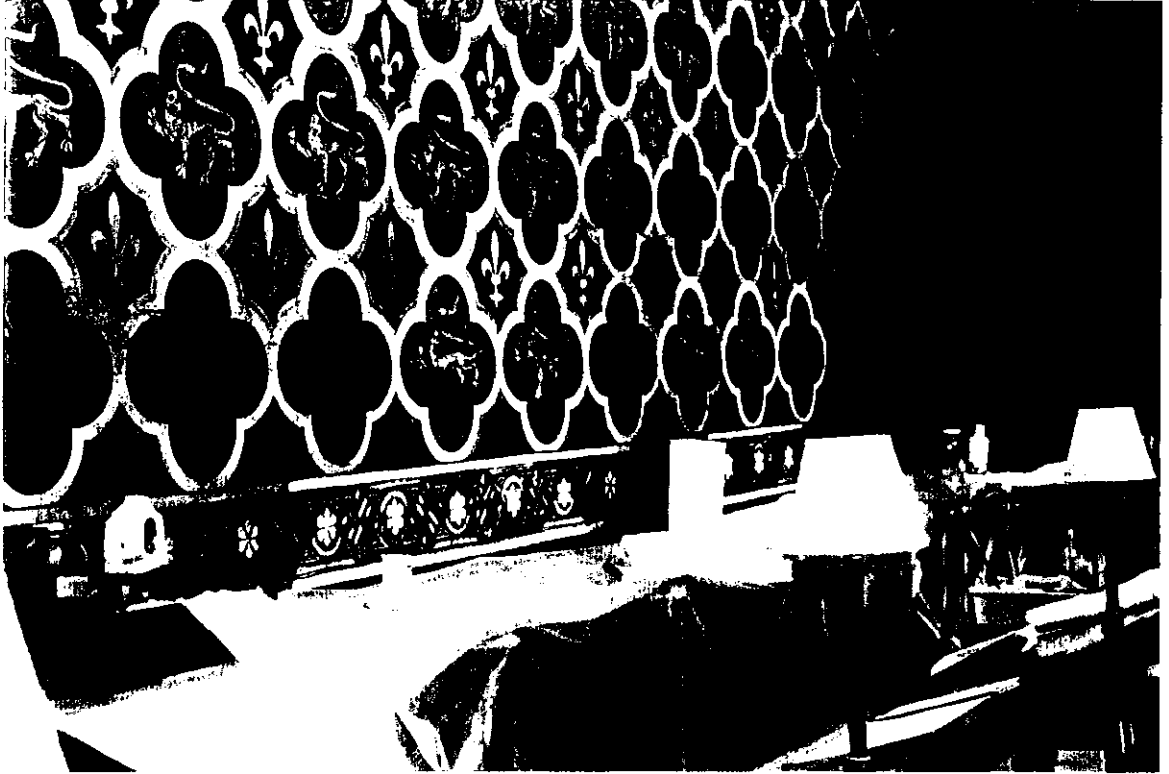
4. cleaning in progress

a) 'Vulpex' spirit soap was used for the cleaning. Three different strengths were employed by adding 1%, 1.7% and 2.5% ammonia. The ammonia was household ammonia with a w/w concentration of 15%. The solvent action of the mix was mellowed with the addition of 33% ordinary tap water; water was also used judiciously for removing soap residues.

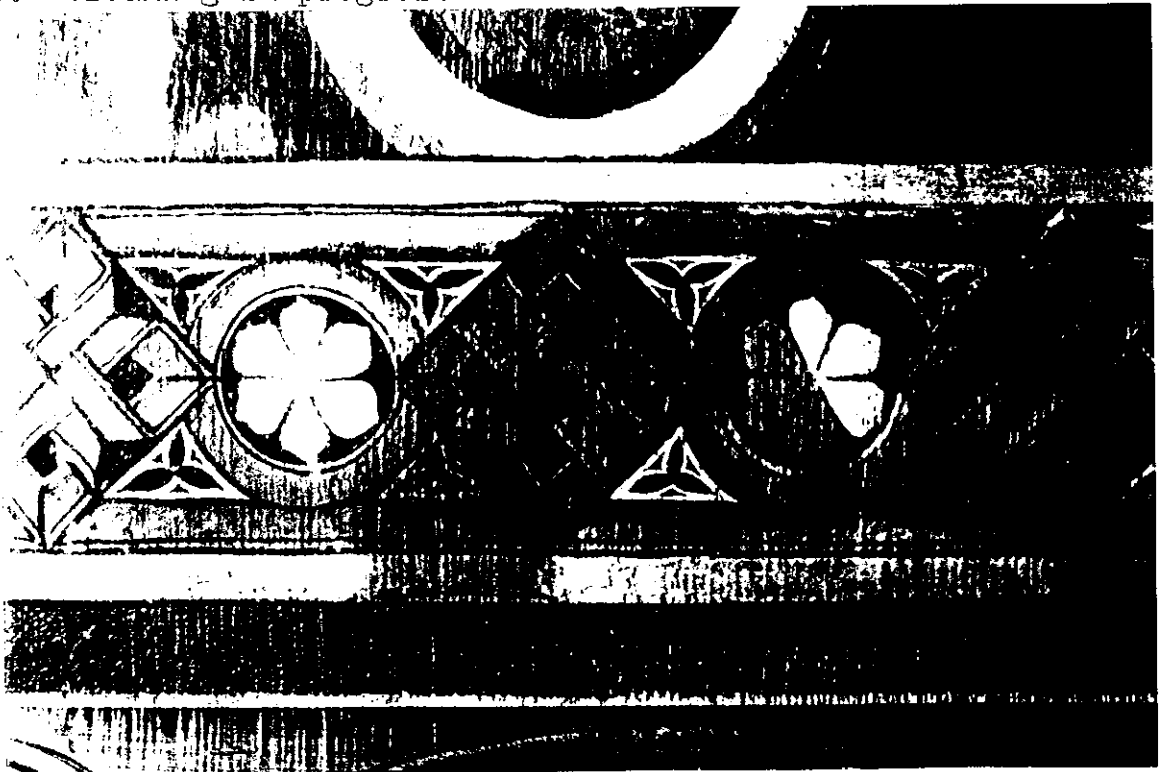
5. cleaning in progress

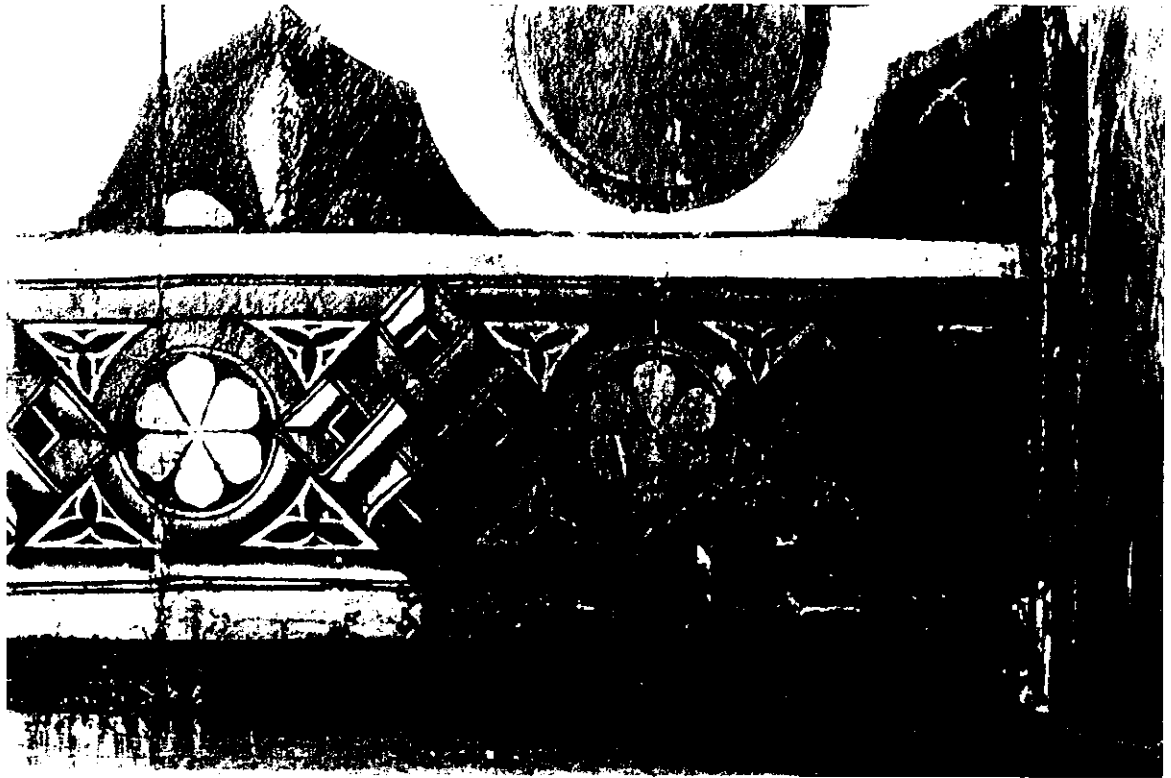
6. cleaning in progress

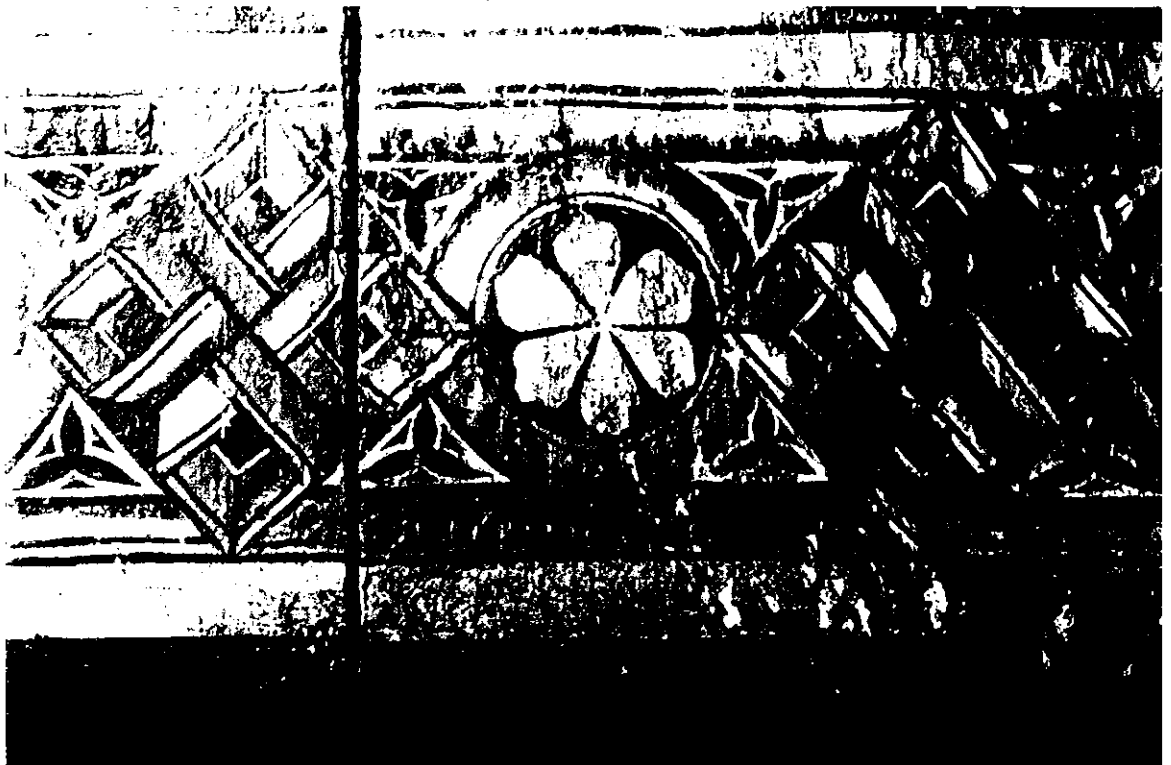
1. Numerous past interventions were evident. It would appear that the Victorian scheme was cleaned and revarnished, possibly twice. Retouching / overpainting had been carried out at various times with different materials, much of it with little attempt to colourmatch. Also there was an emergency paint fixing campaign, most notably on the pulpitum, but also in isolated areas on the north and south walls. This must have been some time after the war as polyvinylacetate appears to have been employed. ( see photograph no.7 )

7. 'remains' of emergency fixing after first clean

d) After the initial cleaning, the excess consolidant from the previous emergency fixing showed up dramatically on the pulpitum. (see photograph 7) . After numerous tests this fixative responded only to 'Nitromors' paint stripper and its removal proved to be particularly painstaking. ( 'Green Label' water washable paintstripper was employed for its useful handling properties; it is supplied as a gel. )

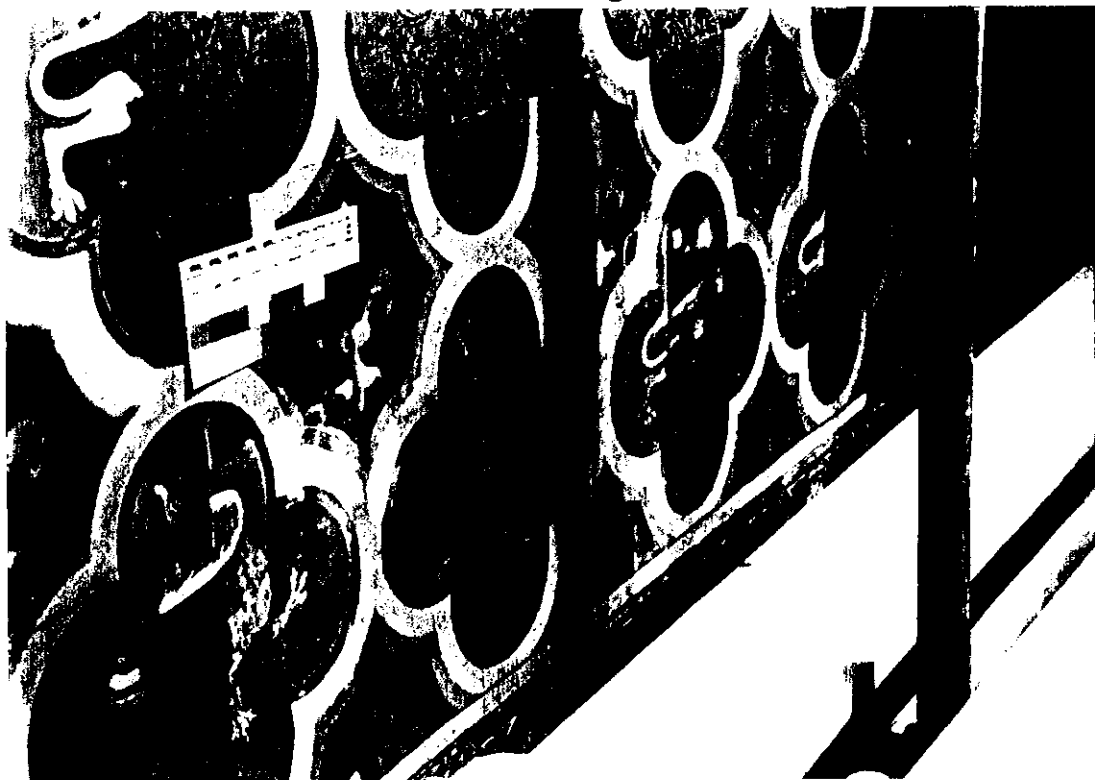
In addition the large area of cleaning tests, recently carried out for the purpose of tendering, had been taken to considerably differing levels.

10. section of area of cleaning tests (before conservation)

The tendering cleaning tests, some of which were very large, all had to be tied in.

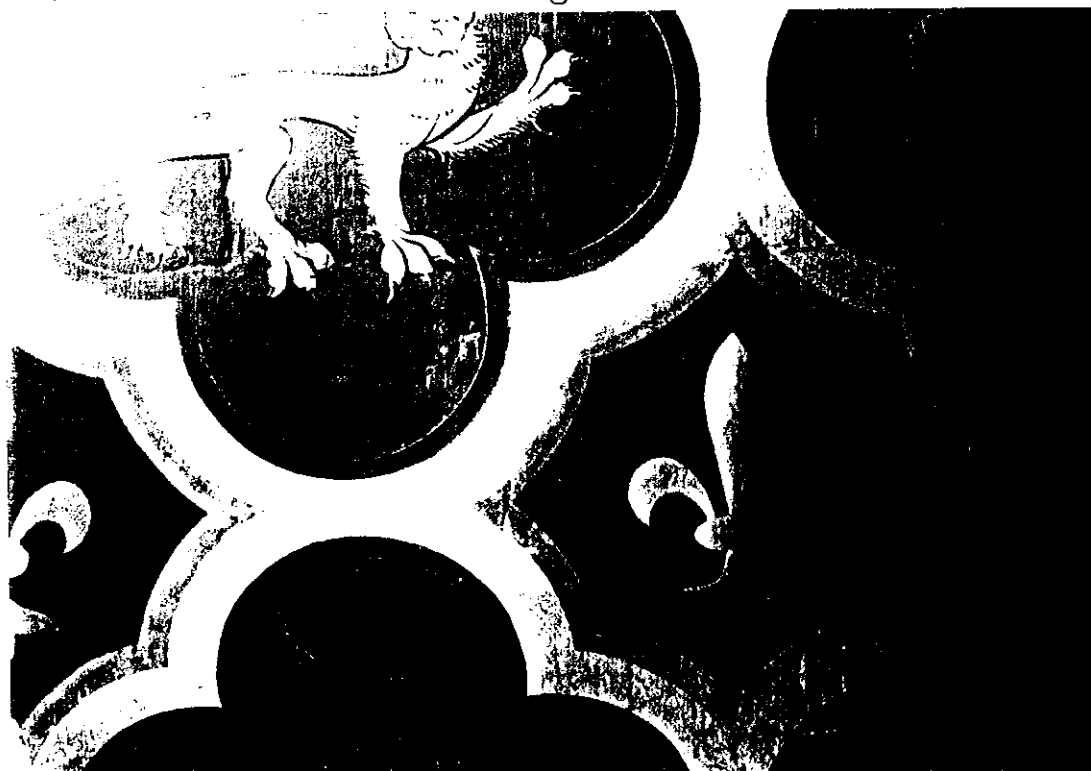
11. Plowden & Smith cleaning test

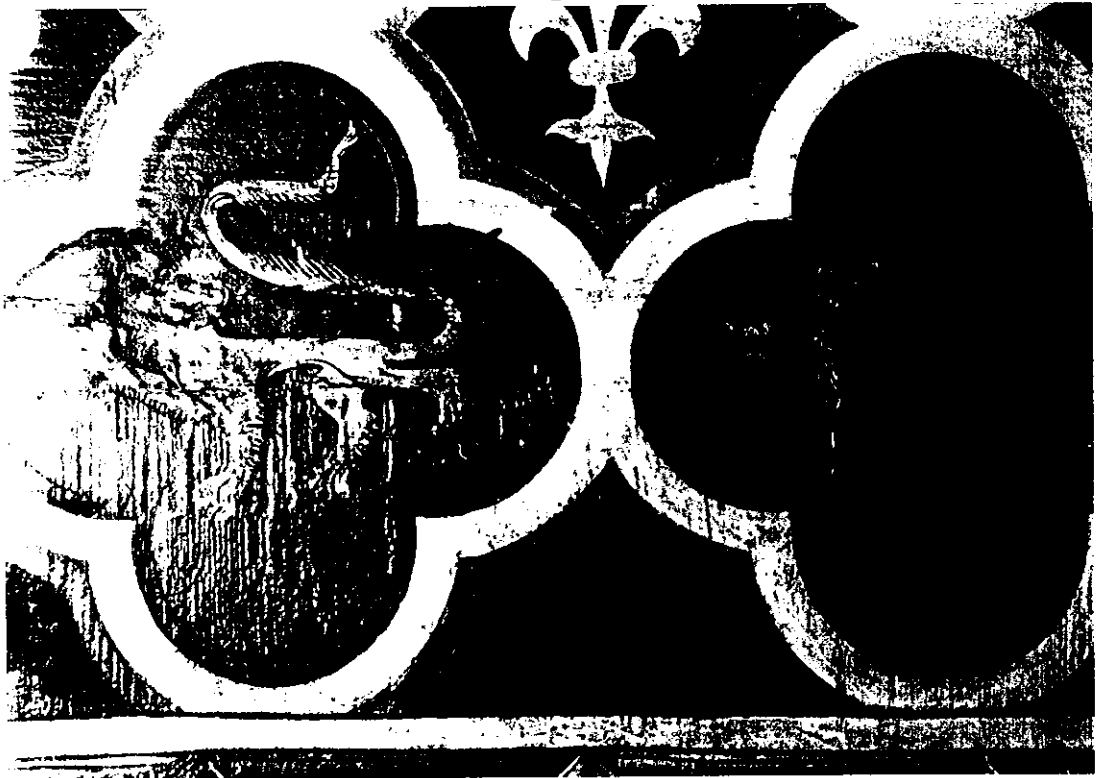
3. The south side in contrast is in the shade and receives direct sunlight only in the early morning. The cleaning on this side had been much more cursory, many of the dark dust deposits were varnished over, and were thus fixed to the wall. The retouching of the white bands between the decorative elements on the south side was much more heavy handed in consequence ( see photographs 12 and 13 ) .

12. detail before retouching

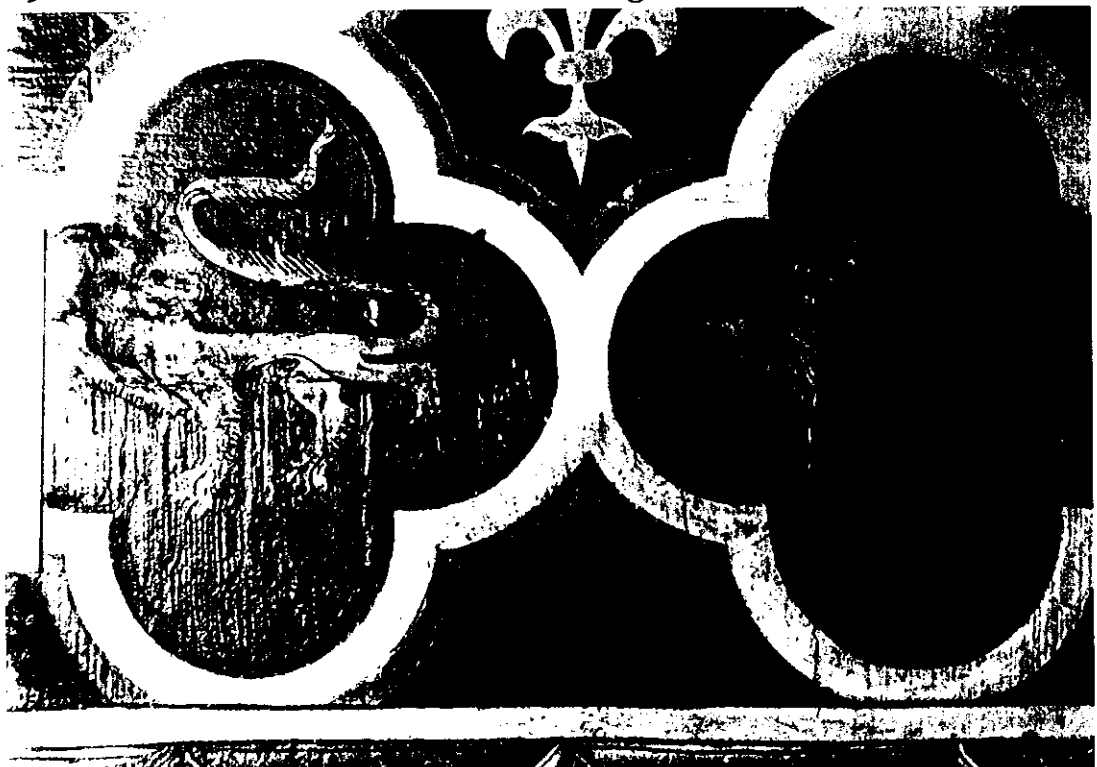
13. same detail after retouching

The retouching was carried out after an insulating varnish layer of 8% 'Paraloid B72' in xylene was applied. 'Maimeri' varnish colours were employed, which were thinned with a 7% solution of 'Paraloid B72' in xylene. This produced a very satisfactory texture and gloss similar to the original, and remains easily distinguishable by ultra-violet light.

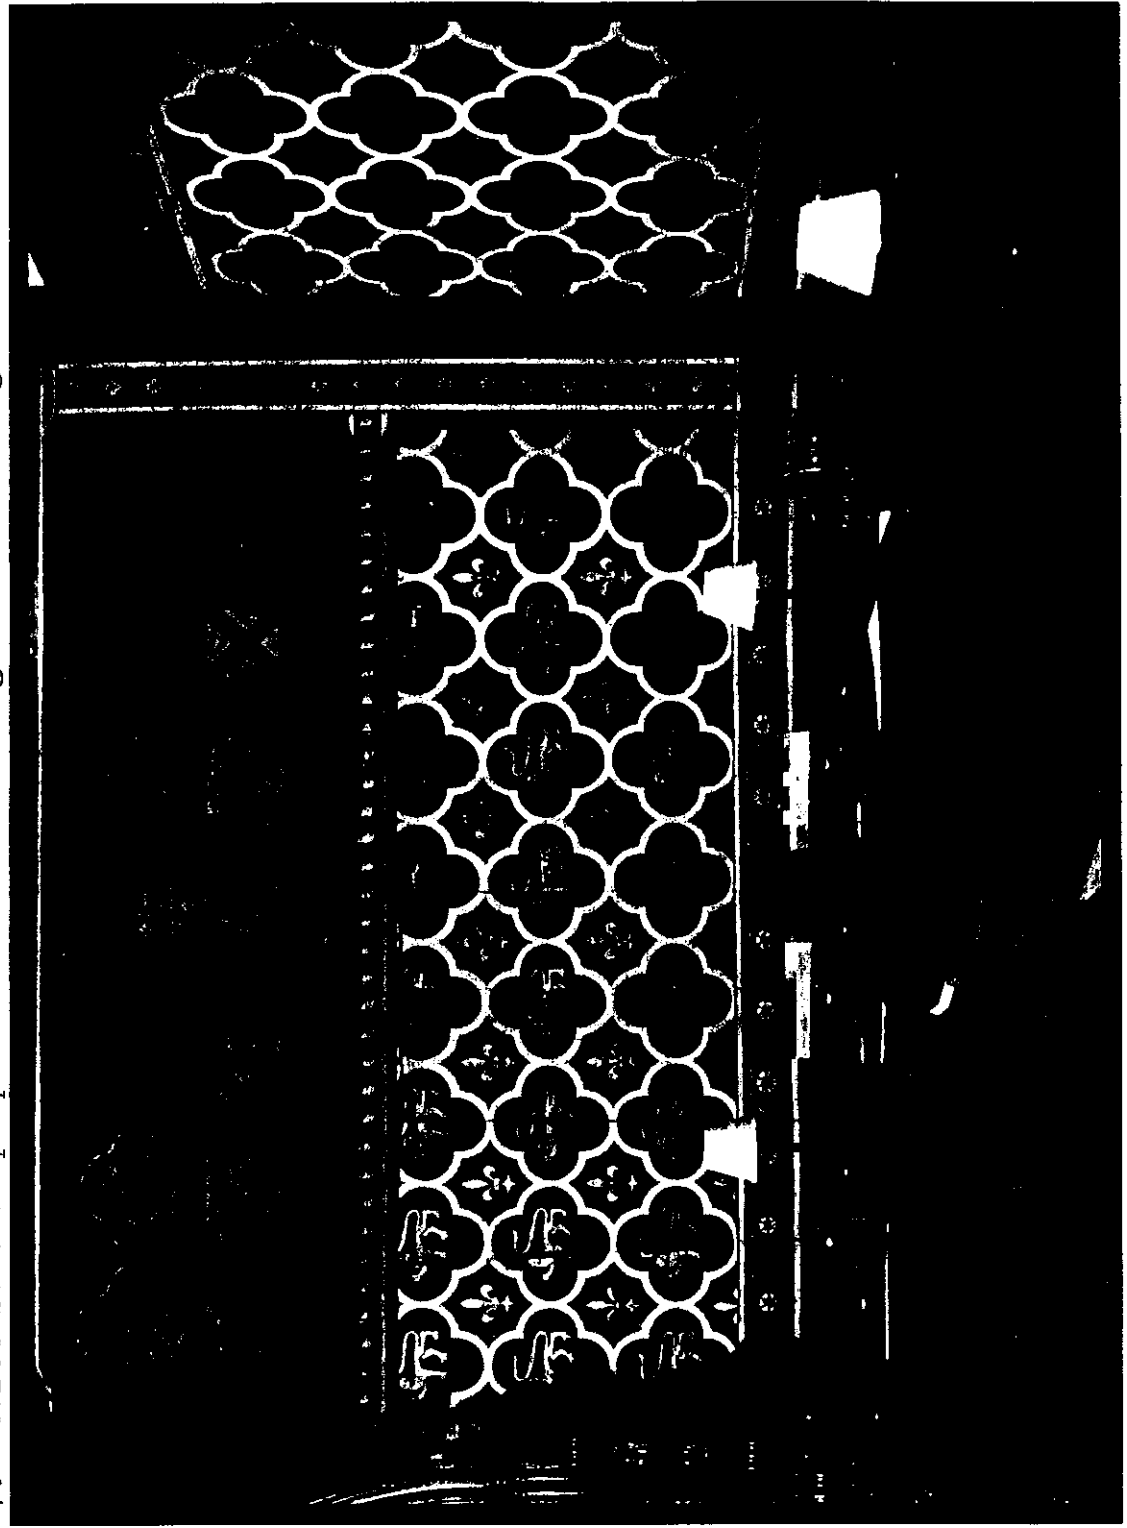
17. north side of pulpitum after retouching and varnishing

'Paraloid B72' was chosen as the final protective varnish. Tests were carried out to establish the best concentration. 7% in xylene was chosen and sprayed on. Like the retouching this is reversible.

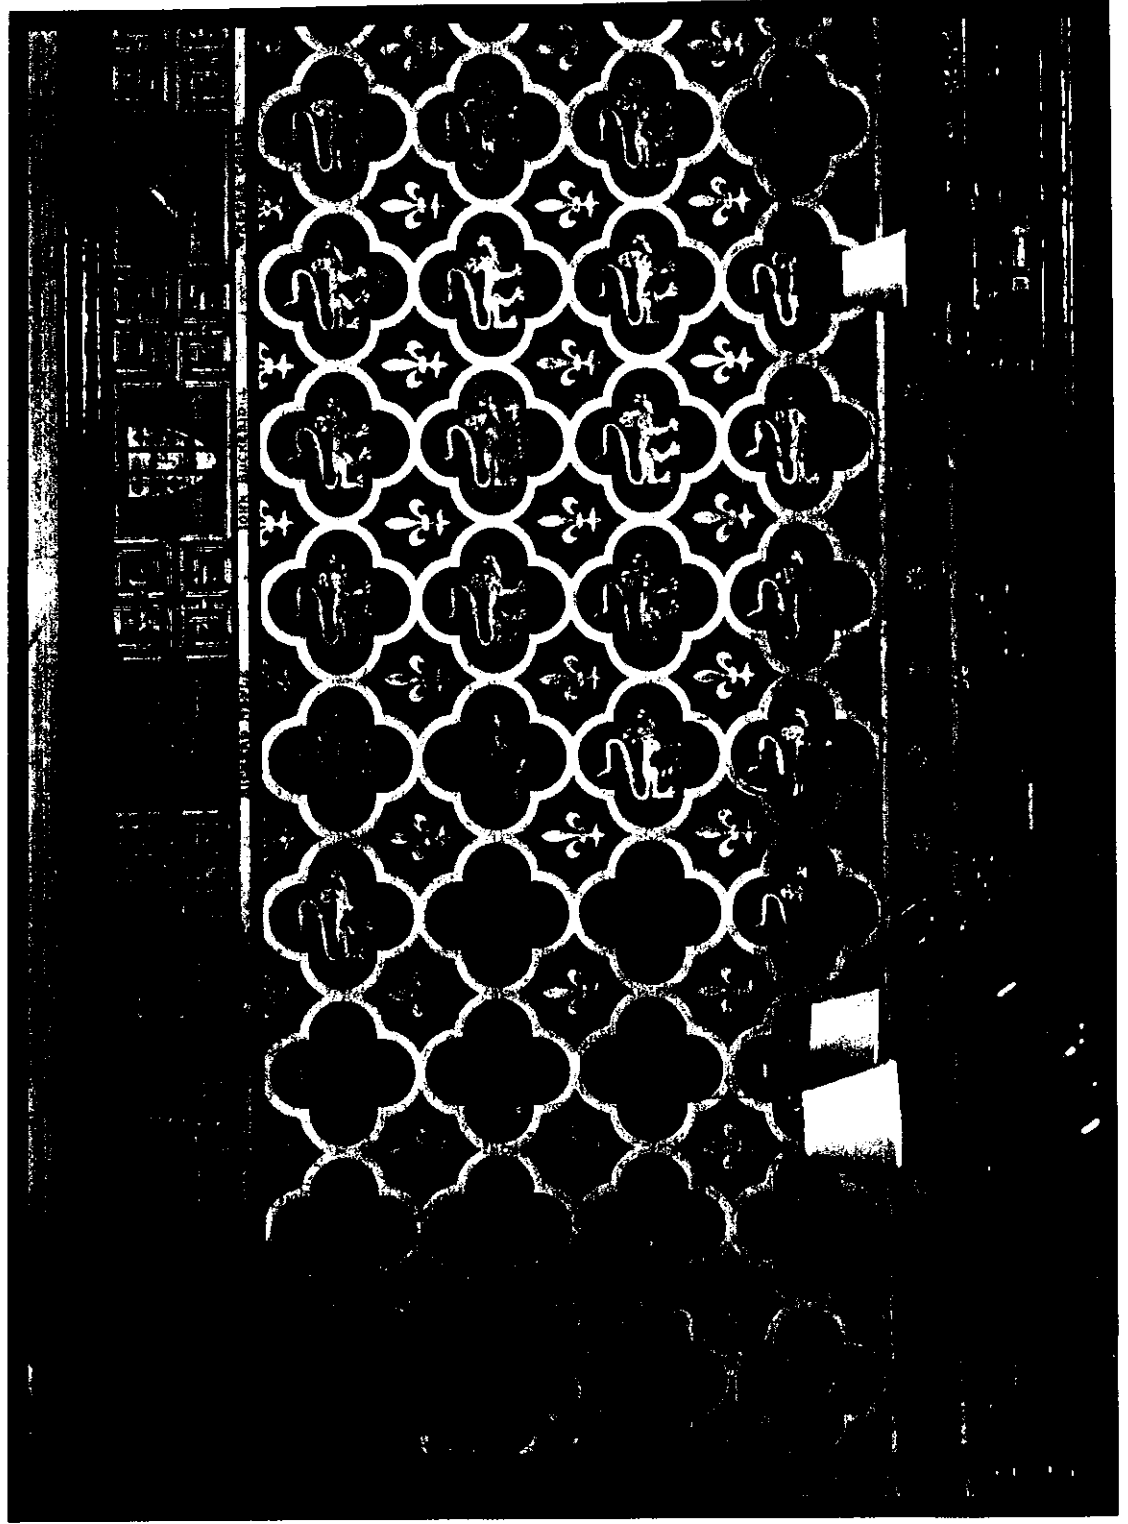
18. w-end of n-wall after first clean

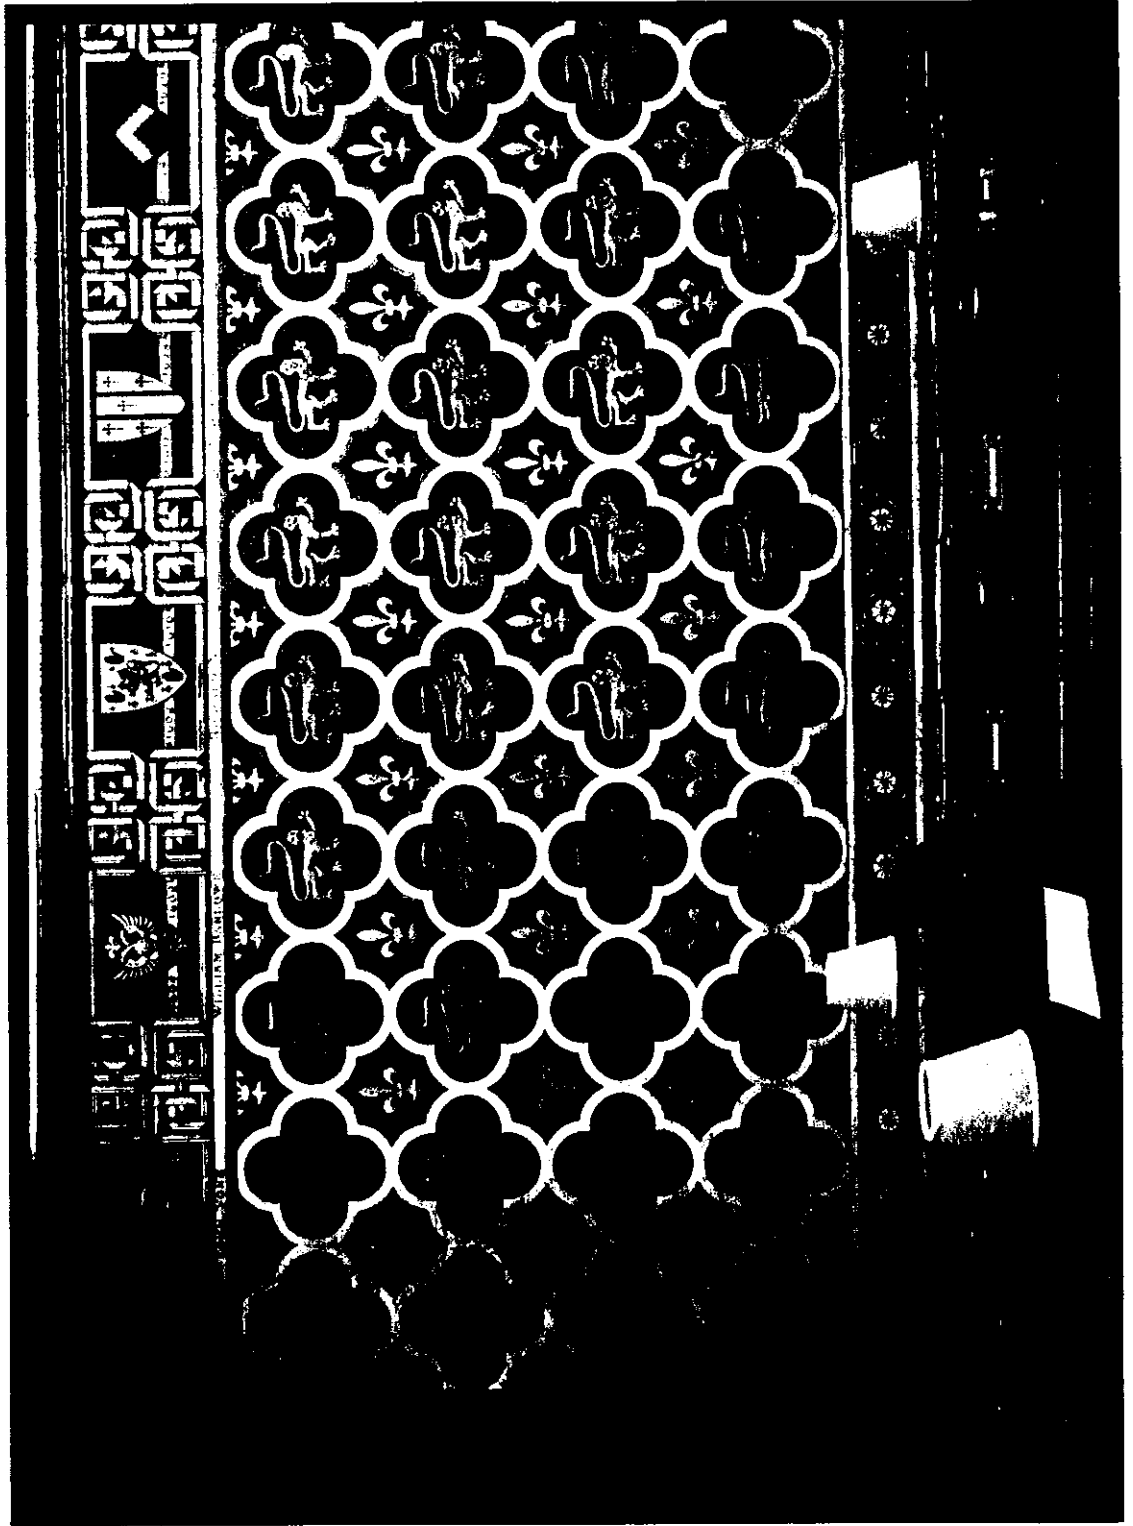
19. w-end of n-wall after retouching and varnishing
