15 May 1996

Conservation Record

ROCHESTER CATHEDRAL: CRYPT

1996 WALL PAINTING CONSERVATION PROGRAMME

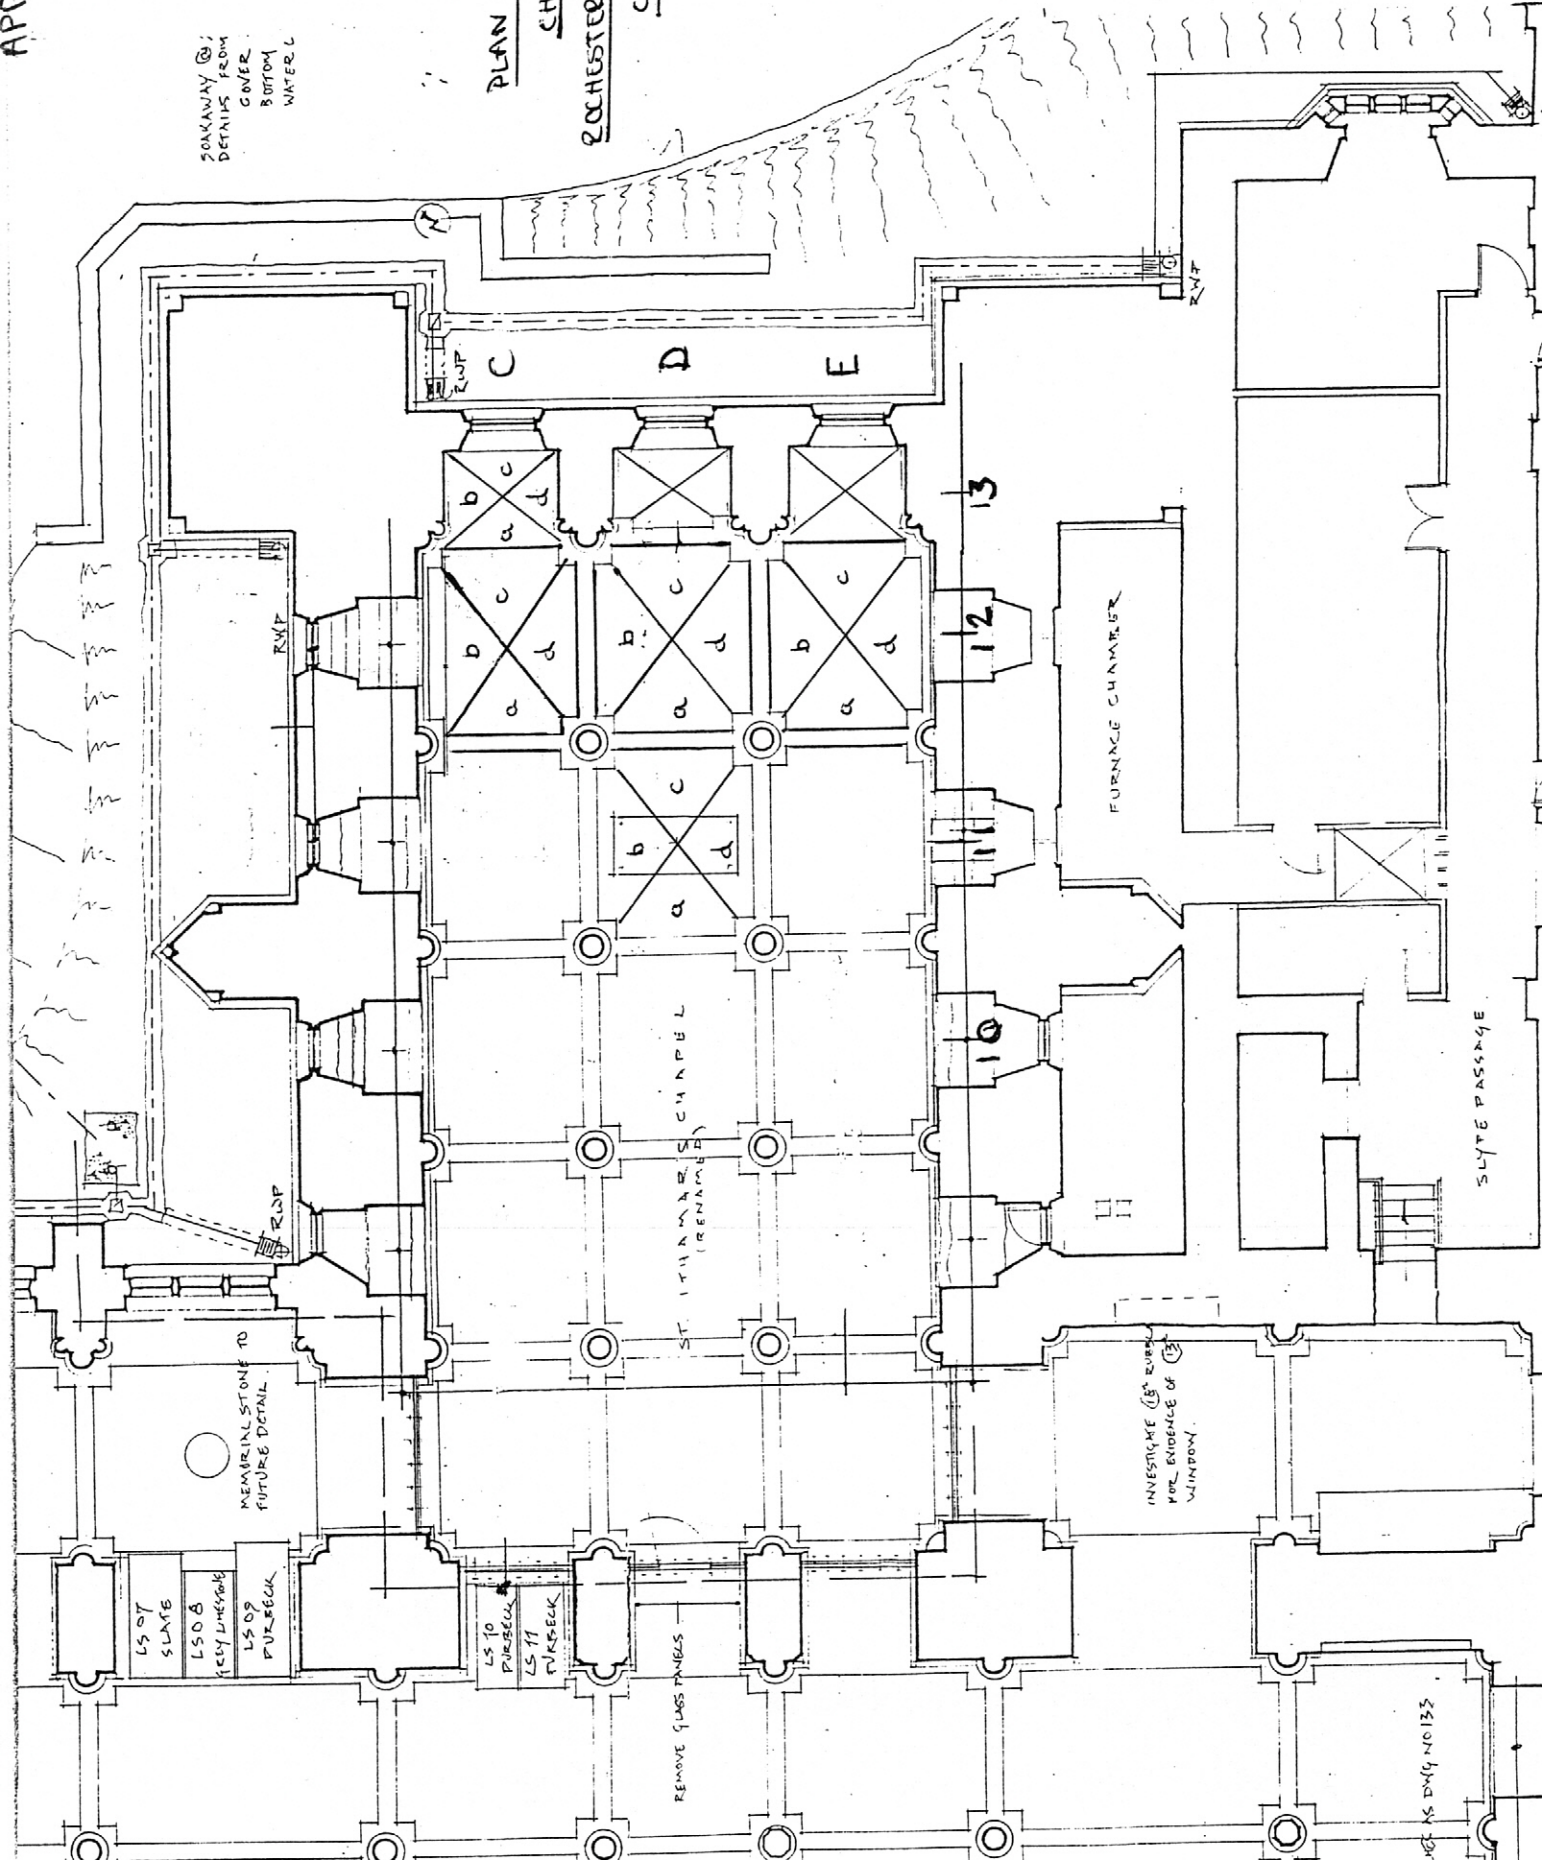
PLAN OF ST ITHAMAR'S
CHAPEL
ROCHESTER CATHEDRAL
CRYPT

HAIR PLASTER REPAIRS TO ORIGINAL
 BACKING PLASTER

'NIMBUS' PLASTER REPAIRS TO ORIGINAL
 BACKING PLASTER

PERRY-LITHGOW PARTNERSHIP REPAIRS TO
 ORIGINAL BACKING PLASTER
